MARINA and SHORELINE CONDITION SURVEY

**Fishing Creek Farm
Anne Arundel County, Maryland**

September 26, 2012

AMA/DBF 2307A001.001

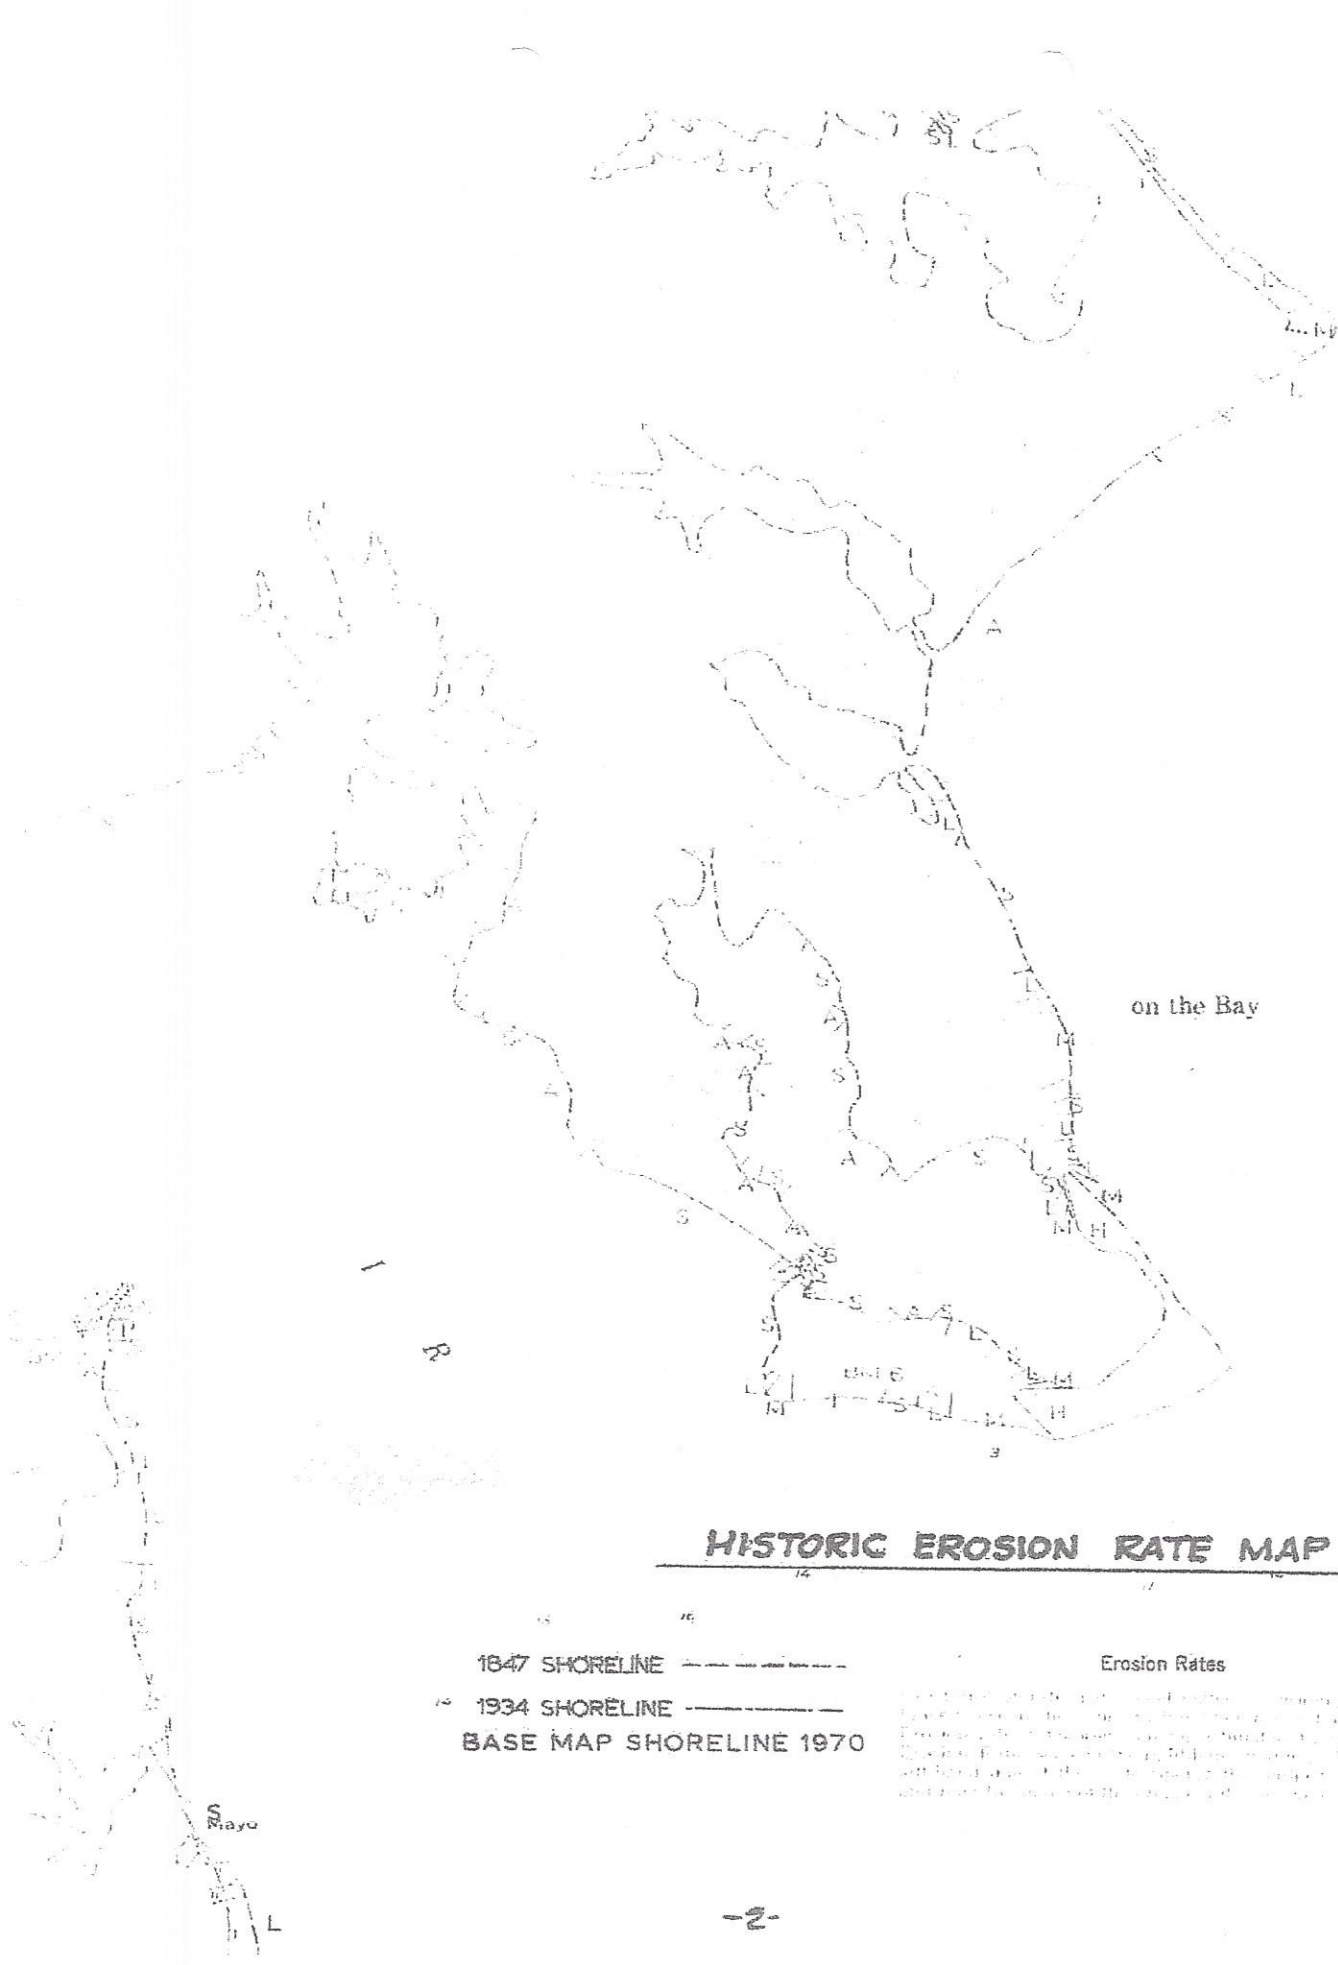
HISTORIC EROSION RATE MAP

The "Historic Erosion Rate Map" shown in Figure 1 compares FCF's shoreline between 1847 and 1970. Generally the shoreline has migrated landward generally <2' per year (classified as 'slight'). However, at the confluence of Cherrytree Cove's northerly shoreline at the point fronting on South River, the erosion historically has varied from slight to Low (2' to 4') to Moderate (4' to 8').

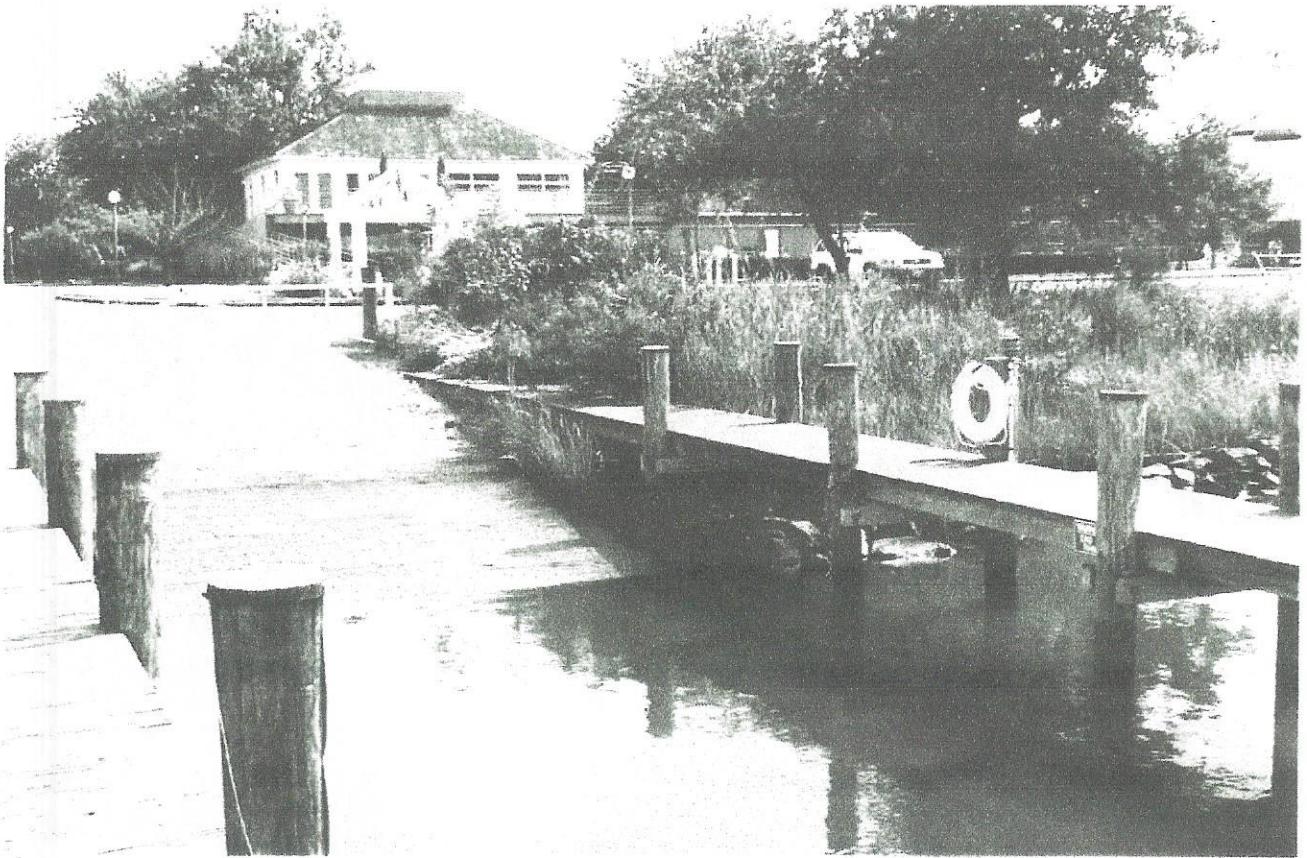
BOAT RAMP AREA: The existing single lane, concrete surfaced boat ramp and courtesy piers (Photo 1) appeared to be in good condition except for twisting and warping of the pier's deck planks. Although the ramp has a shallow toe (about -2' MLW) and the courtesy piers are constructed from relatively small sized piles and lumber, it is AMA/DBF's opinion that the boat ramp facility (except for deck replacement) has >15 years of life remaining before significant improvements are needed. The decking or portions thereof should be replaced within the next five years at an estimated cost of \$30 to \$35/ LF. A "home-made" style hinged timber gangway resting on floating pontoons is located at the waterward end of the easterly courtesy pier allowing access to the water for persons launching canoes and kayaks. Since the gangway articulates constantly with the tides and boat wakes, regular maintenance should be provided to ensure its continued safe use.

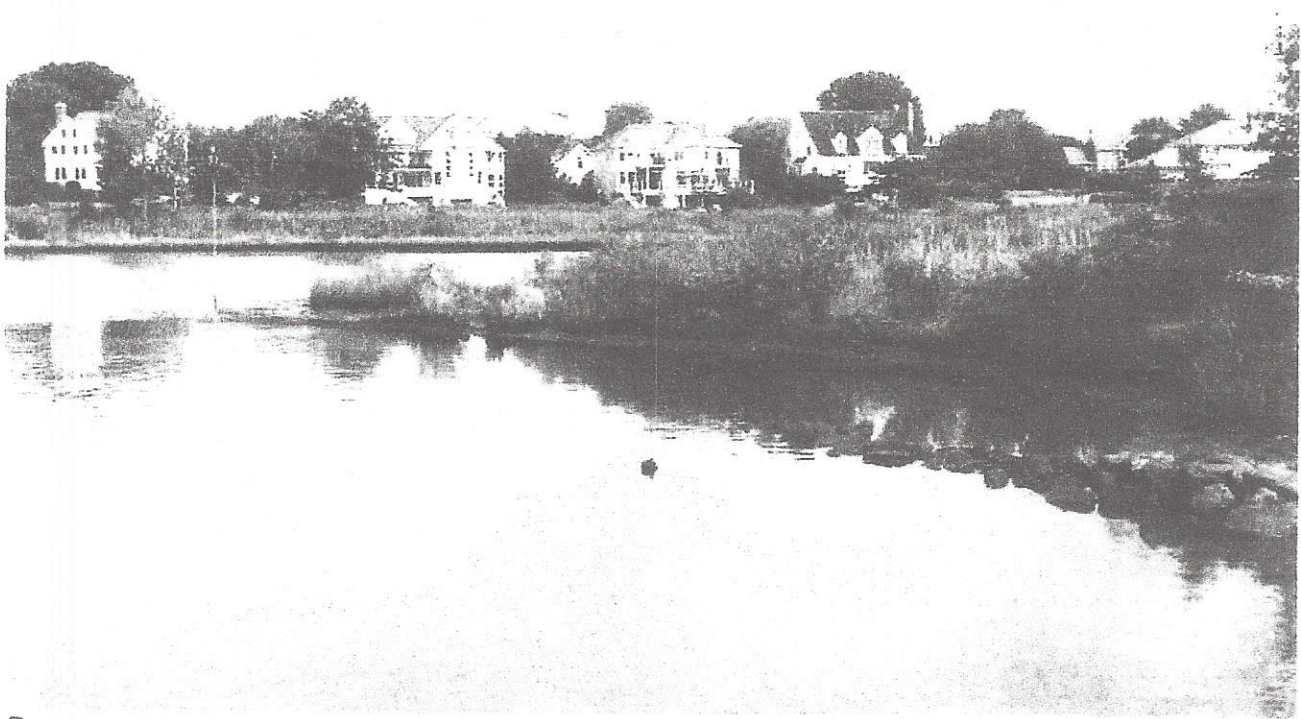
3

A low profile dumped riprap sill extends from both sides of the boat ramp along the mean low water line paralleling the shoreline (Photo 2 and 3). A narrow ban of wetland vegetation provides a protective buffer between the sill and the vertical bank at the road.

SHORELINE AT BOAT RAMP / MARINA AREAS: Wetland vegetation provides limited protection to the vertical banks located landward of the boat ramp (Photo 3) and marina areas (Photo 4 and 5). Drain outlets encased in stone filled gabion baskets are located at two separate areas along the shore. Scattered areas of the shoreline are void of wetland vegetation thereby exposing several sections of the vertical bank to erosive wave action (Photo 6). It is AMA/DBF's opinion that at a minimum, *Spartina alterniflora* should be sprigged between the mid and high tide lines at these areas (\$0.70/sf to \$0.85/sf). If funding allows, the sprigging should be supplemented with construction of a low profile revetment (Figure 3) located landward of the vegetation along the vertical bank scarp at an additional estimated cost of \$150 to \$250/ft. Alternately, a formal living shoreline consisting of a low profile stone sill and 20' to 30' width of

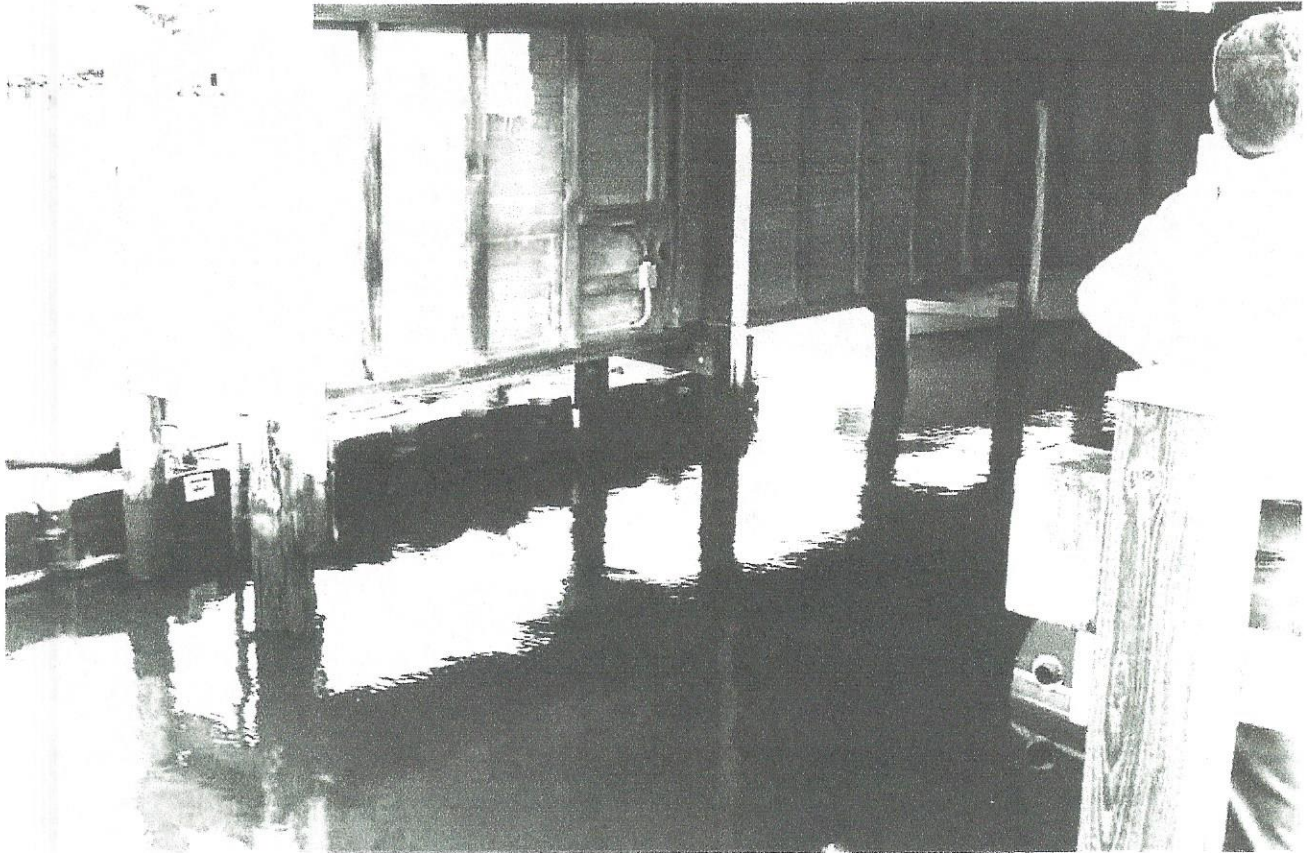
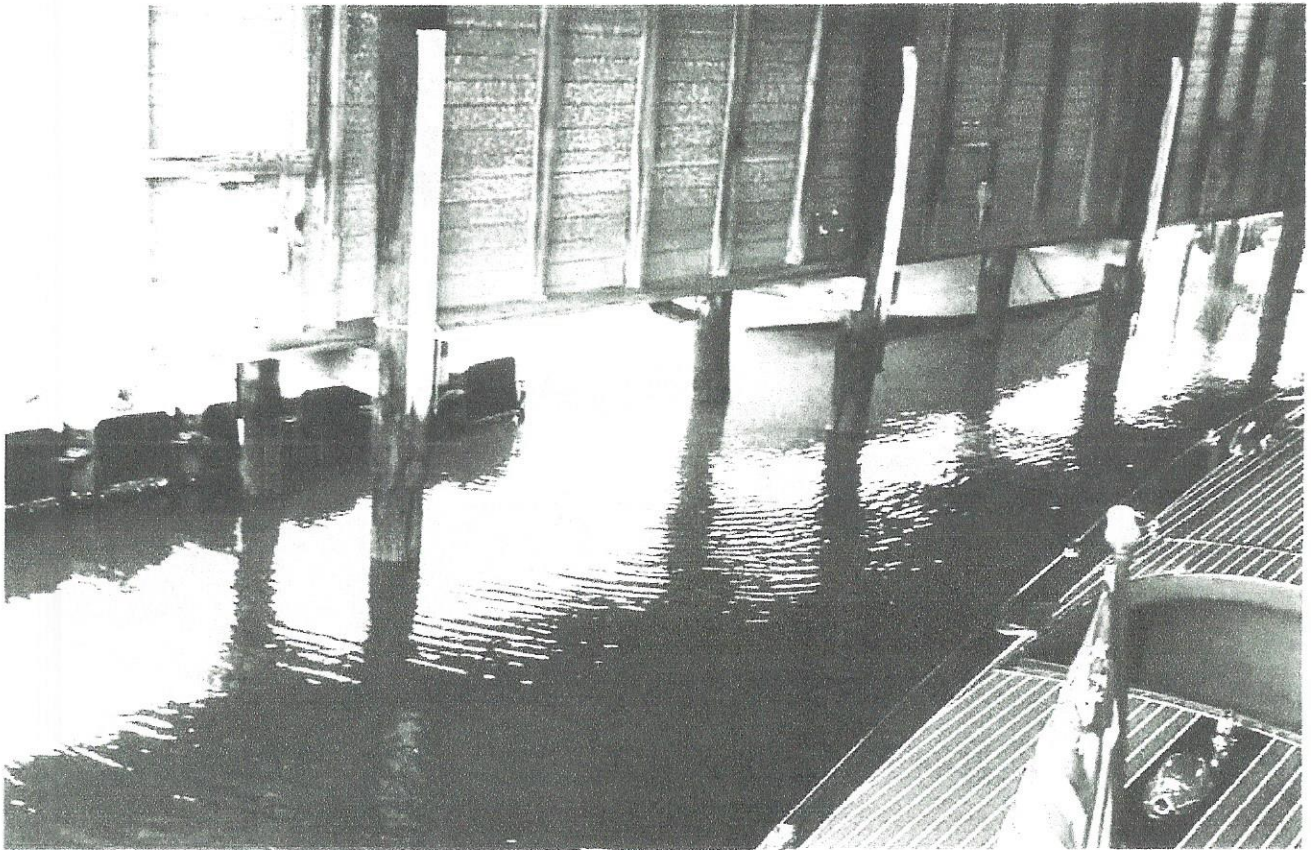
BOAT HOUSE

The existing boat house located at the landward end of the marina's collector pier is in a general state of disrepair. Windows to the boathouse are broken, the electrical service is questionable and the foundation piles appear to be reaching the end of their serviceable life (Photo "Boathouse"). It is AMA/DBF's opinion that the boat house will need significant improvements or total replacement within the next 5 to 10 years at an estimated cost of \$150K to \$200K.

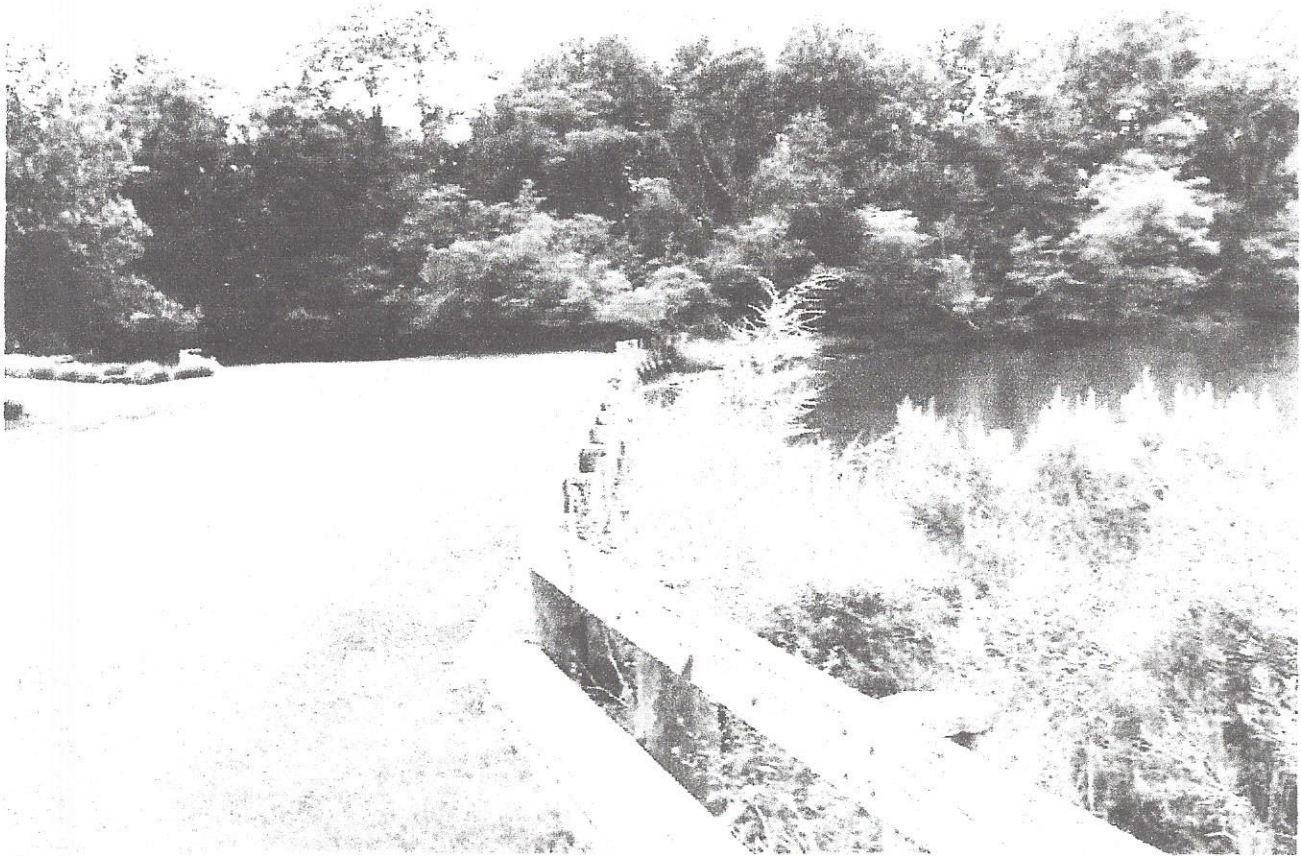
9

BULKHEADED SHOULDER ALONG CHERRYTREE LANE: Approximately ¼ mile east of the Clubhouse along the northerly shoulder of Cherrytree Lane, a timber bulkhead (+/- 240 L.F.) protects the paved roadway against erosion from tidal waters of Duvall Creek (Photo 9). The batter pile supported bulkhead appears to be in generally good condition except for twisted and warped timber capboards and evidence of minor soil leakage (Photo 10) at several locations. It appears that the existing structure had previously replaced an older bulkhead. Decayed anchor rods (>1" dia.) extend landward through the existing T&G sheeting from the existing bulkhead's vertical pile. AMA/DBF theorizes that this rod is attached to the earlier bulkhead's buried anchor piles thereby creating a redundant anchorage system. It is AMA/DBF's opinion that the existing timber bulkhead has >15 years of life remaining before significant improvements are needed; however, if replaced (Figure 7), the estimated cost would be from \$900 to \$1200/LF.

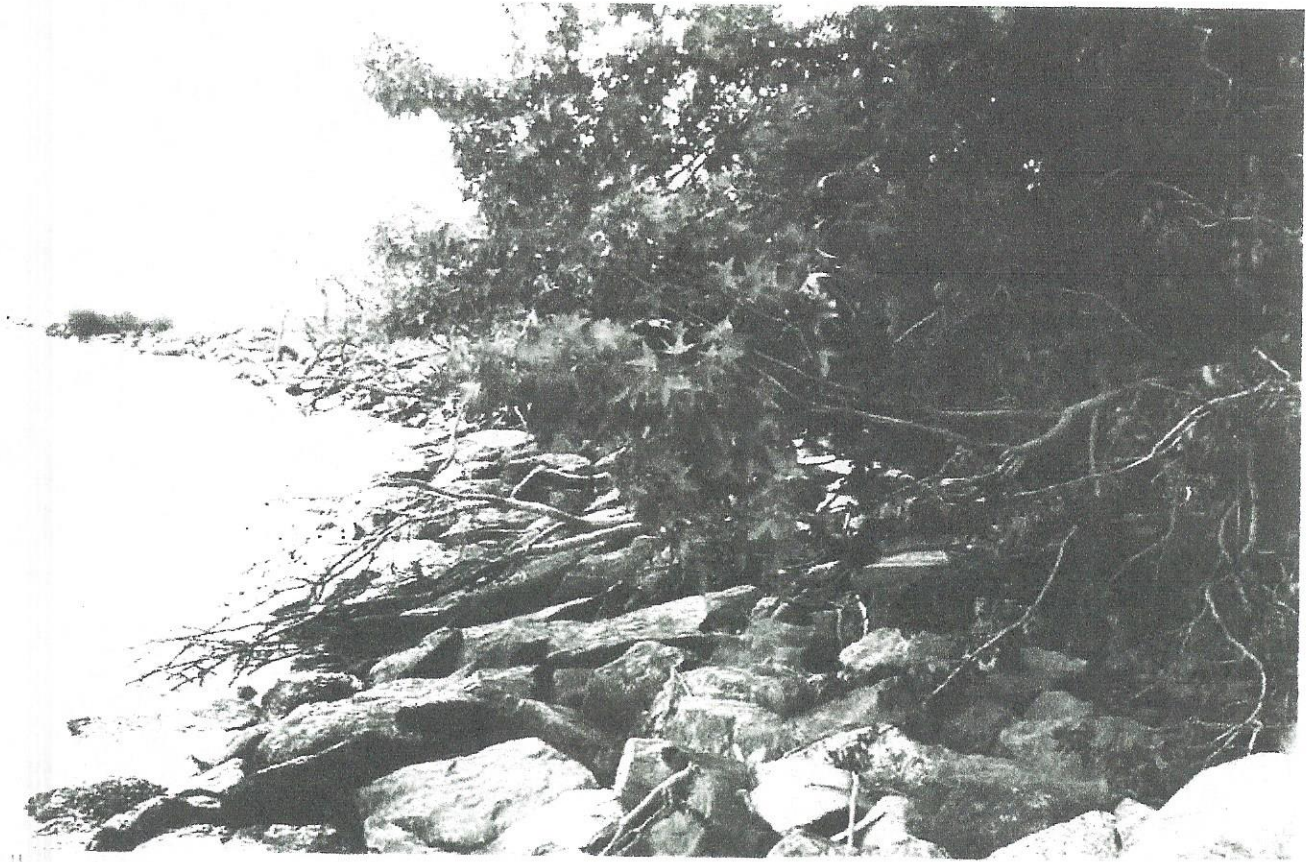
11

Cherrytree Lane constructed the existing timber bulkhead located at the end of the right-of-way. A stone revetment with splash apron provides protection against erosion west of the bulkhead (Photo 11). The revetment appears to be in generally good condition although debris litters the top of the structure (Photo 12). Unlike timber bulkheads which rot after years of service and could ultimately have a catastrophic failure if not maintained, stone revetments do not rot. Correctly designed and constructed stone revetments typically require maintenance only after severe storm events that exceed the design level of the structure and then typically only requiring repositioning of displaced armor stone units. It is AMA/DBF's opinion that the existing stone revetment has >15 years of life remaining before significant maintenance/ improvements may be needed.
