MARINA and SHORELINE CONDITION SURVEY

**Fishing Creek Farm
Anne Arundel County, Maryland**

September 26, 2012

**ANDREWS, MILLER AND ASSOCIATES
A Division of Davis, Bowen & Friedel, Inc.
106 N. Washington Street
Easton, Maryland 21601**

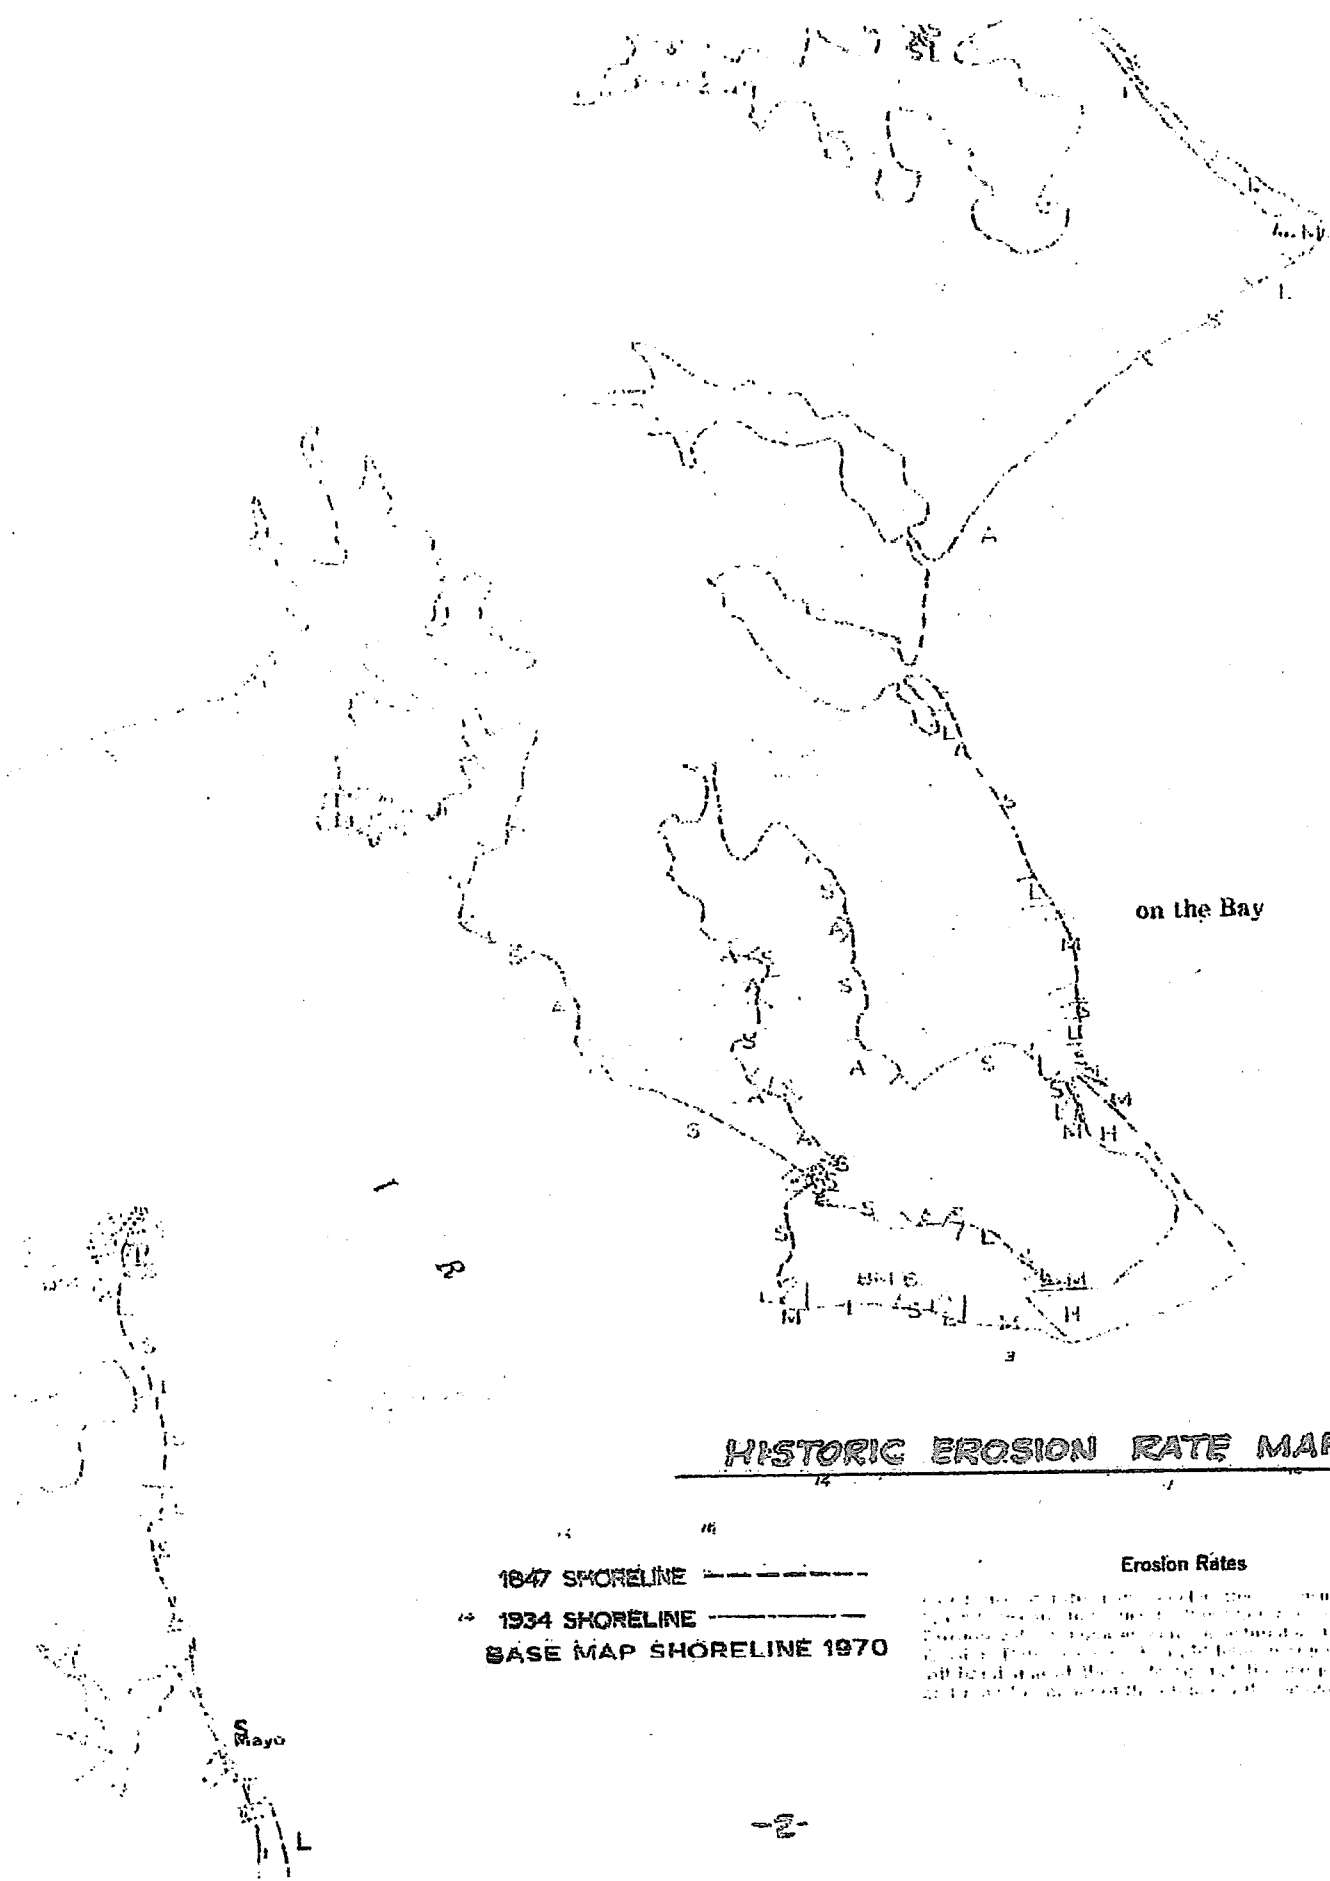
HISTORIC EROSION RATE MAP

The "Historic Erosion Rate Map" shown in Figure 1 compares FCF's shoreline between 1847 and 1970. Generally the shoreline has migrated landward generally <2' per year (classified as 'slight'). However, at the confluence of Cherrytree Cove's northerly shoreline at the point fronting on South River, the erosion historically has varied from slight to Low (2' to 4') to Moderate (4' to 8').

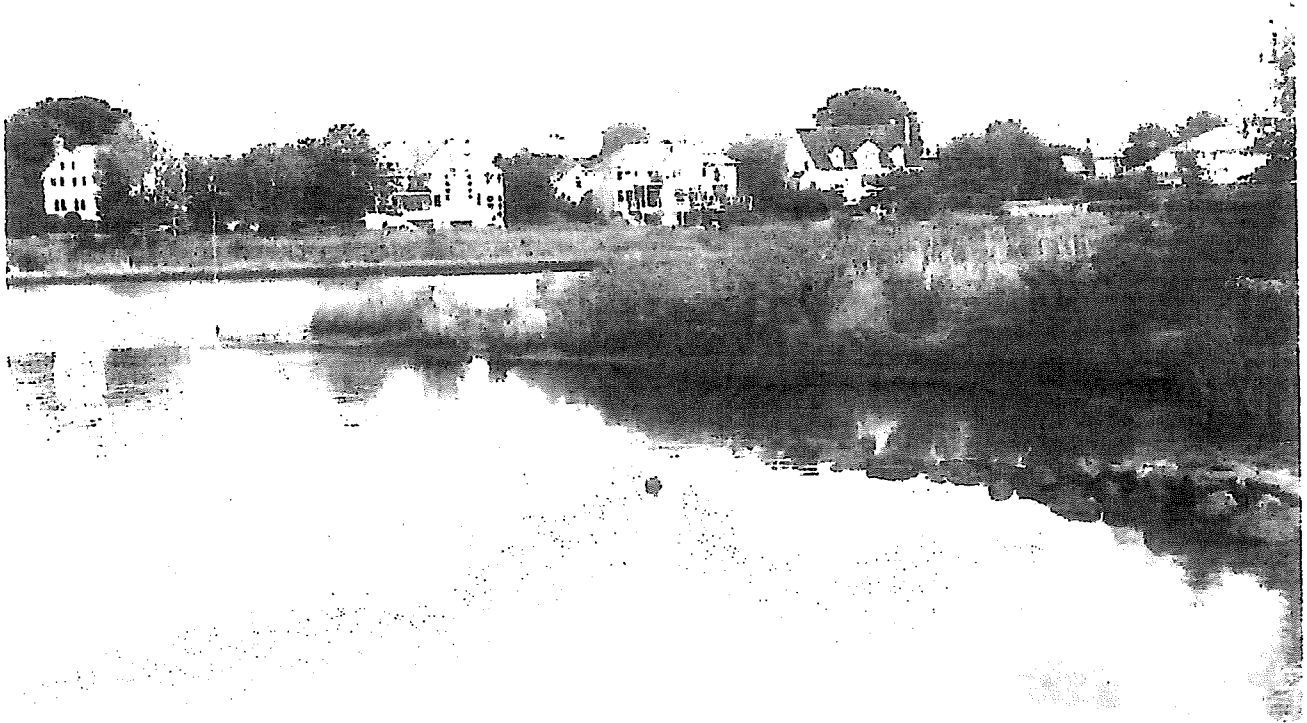
3

A low profile dumped riprap sill extends from both sides of the boat ramp along the mean low water line paralleling the shoreline (Photo 2 and 3). A narrow ban of wetland vegetation provides a protective buffer between the sill and the vertical bank at the road.

SHORELINE AT BOAT RAMP / MARINA AREAS: Wetland vegetation provides limited protection to the vertical banks located landward of the boat ramp (Photo 3) and marina areas (Photo 4 and 5). Drain outlets encased in stone filled gabion baskets are located at two separate areas along the shore. Scattered areas of the shoreline are void of wetland vegetation thereby exposing several sections of the vertical bank to erosive wave action (Photo 6). It is AMA/DBF's opinion that at a minimum, *Spartina alterniflora* should be sprigged between the mid and high tide lines at these areas (\$0.70/sf to \$0.85/sf). If funding allows, the sprigging should be supplemented with construction of a low profile revetment (Figure 3) located landward of the vegetation along the vertical bank scarp at an additional estimated cost of \$150 to \$250/ft. Alternately, a formal living shoreline consisting of a low profile stone sill and 20' to 30' width of

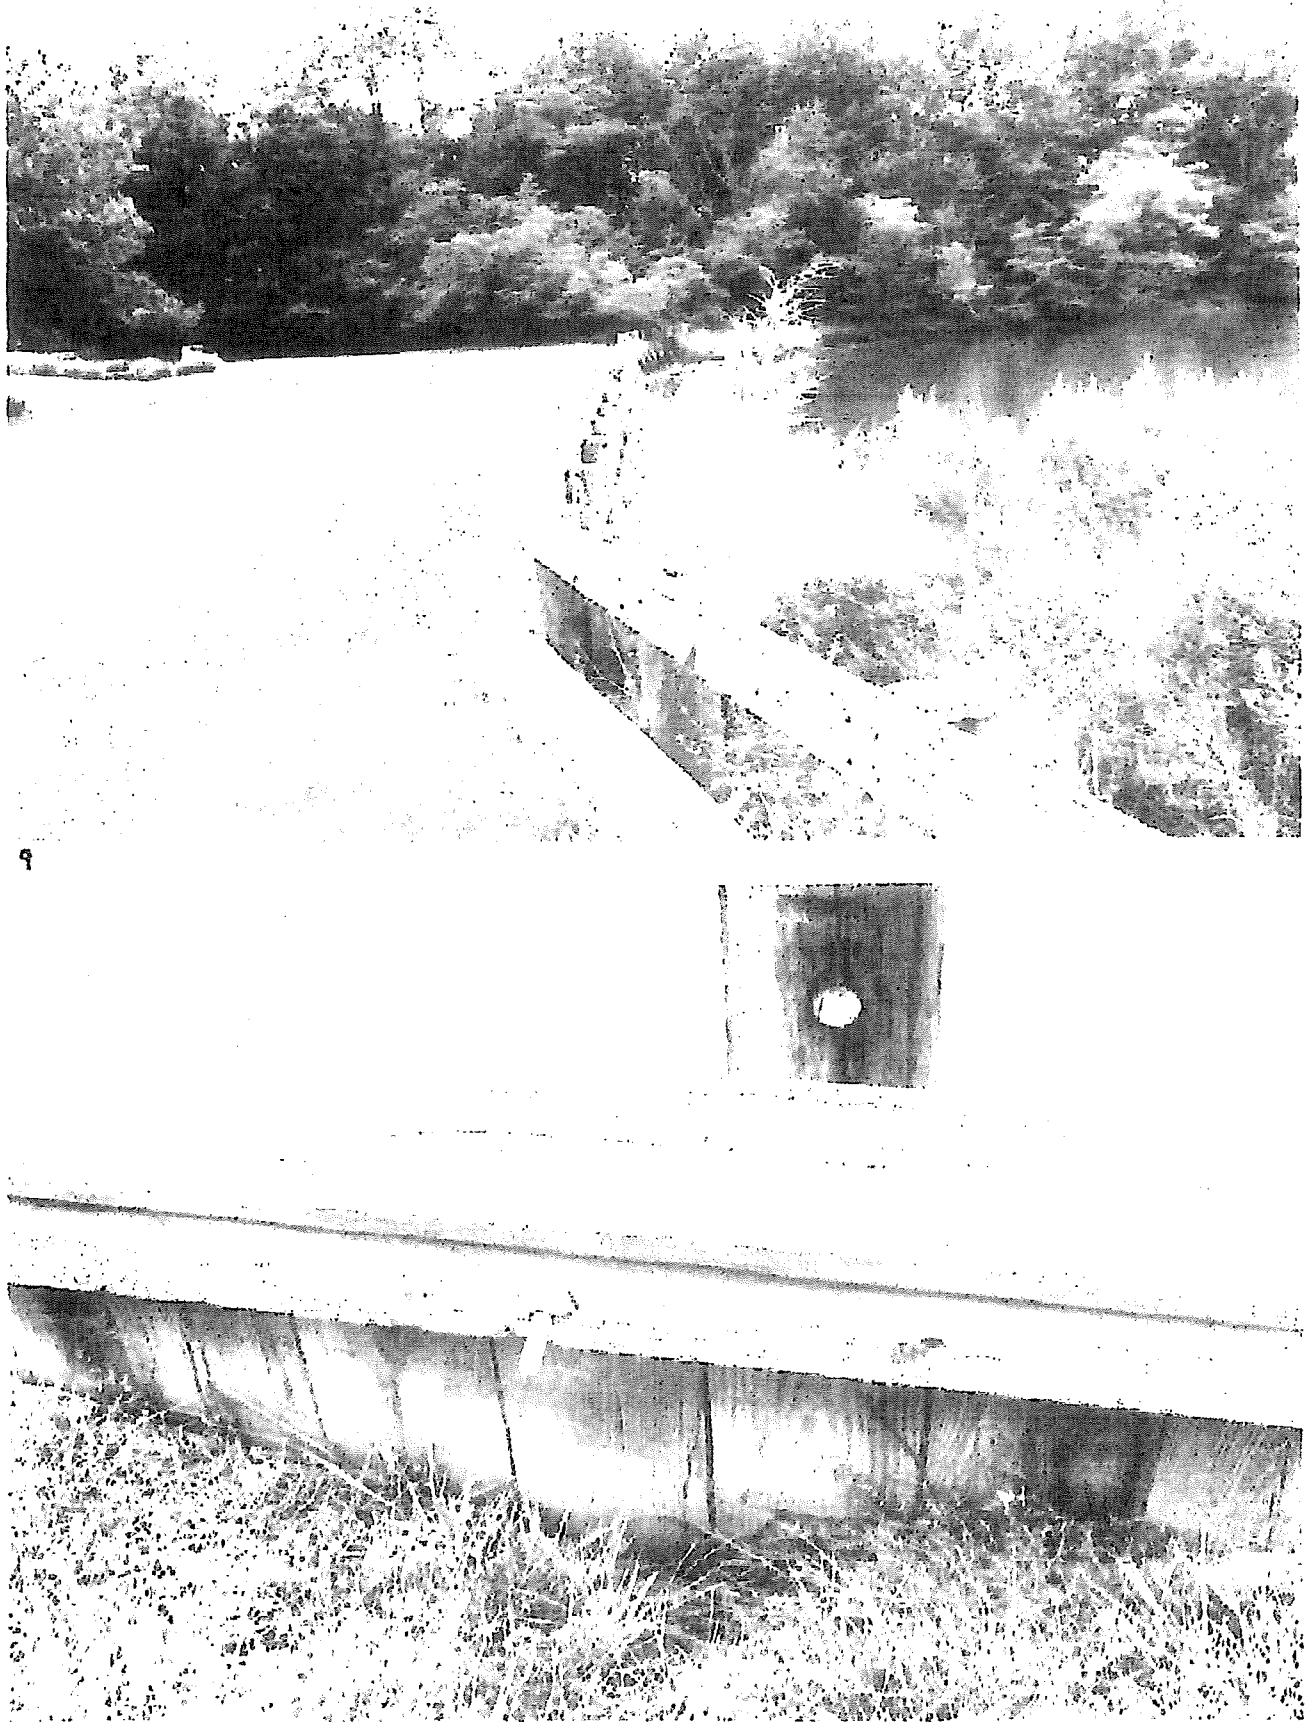
9

BULKHEADED SHOULDER ALONG CHERRYTREE LANE: Approximately ¼ mile east of the Clubhouse along the northerly shoulder of Cherrytree Lane, a timber bulkhead (+/- 240 L.F.) protects the paved roadway against erosion from tidal waters of Duvall Creek (Photo 9). The batter pile supported bulkhead appears to be in generally good condition except for twisted and warped timber capboards and evidence of minor soil leakage (Photo 10) at several locations. It appears that the existing structure had previously replaced an older bulkhead. Decayed anchor rods (>1" dia.) extend landward through the existing T&G sheeting from the existing bulkhead's vertical pile. AMA/DBF theorizes that this rod is attached to the earlier bulkhead's buried anchor piles thereby creating a redundant anchorage system. It is AMA/DBF's opinion that the existing timber bulkhead has >15 years of life remaining before significant improvements are needed; however, if replaced (Figure 7), the estimated cost would be from \$900 to \$1200/LF.

AMA/DBF recommends that the capboard be replaced and the sump areas be repaired when funding becomes available. The estimated cost for these improvements is on the order of \$4K to \$8K.

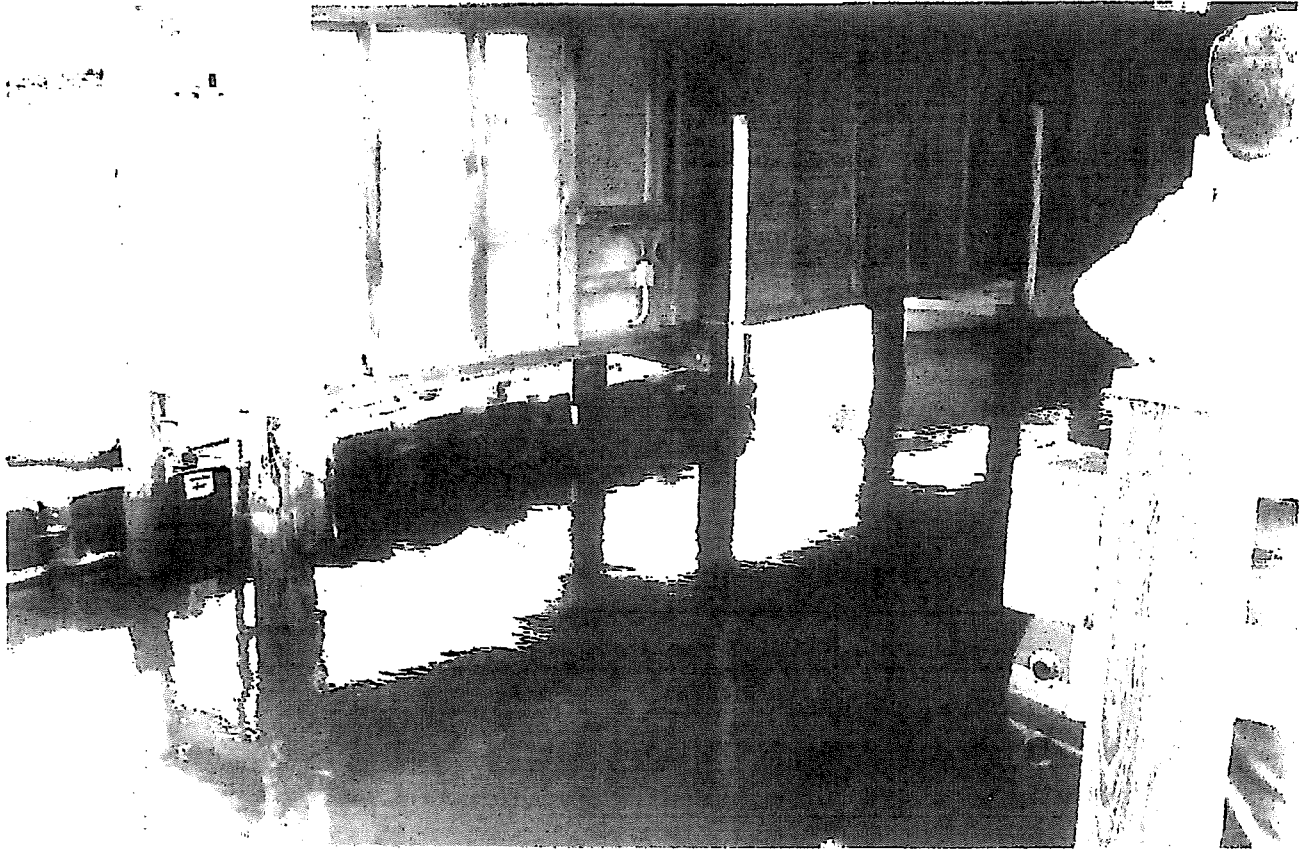
BOAT HOUSE

The existing boat house located at the landward end of the marina's collector pier is in a general state of disrepair. Windows to the boathouse are broken, the electrical service is questionable and the foundation piles appear to be reaching the end of their serviceable life (Photo "Boathouse"). It is AMA/DBF's opinion that the boat house will need significant improvements or total replacement within the next 5 to 10 years at an estimated cost of \$150K to \$200K.
