LEVEL 2 REPLACEMENT RESERVE REPORT FY 2023 FISHING CREEK FARM

FISHING CREEK FARM

ANNAPOLIS, MARYLAND

June 27, 2022

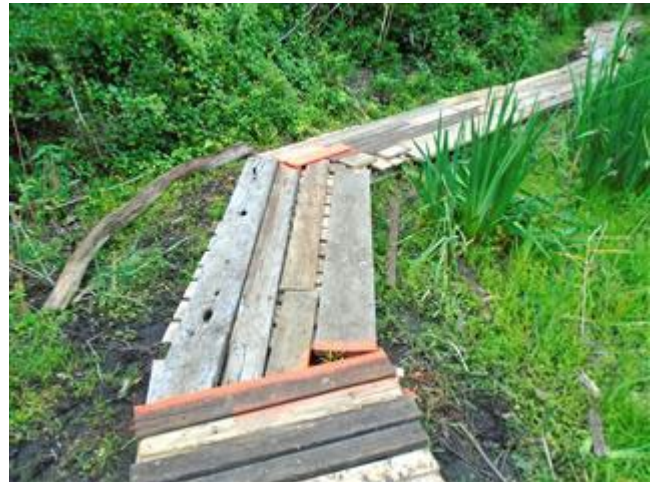
Pedestrian Bridge. The Association maintains a large pedestrian bridge on the west side of Hidden River View Road that provides access to Cherrytree Cove. The bridge according to the Association was constructed in or around 2005. The bridge includes on-ground walkways and is elevated over the water section. The latter is supported by marine-grade piling. The bridge appears to be structurally sound, and the decking and railings are in fair conditions.

When installing new decking, the installation of a self-healing flashing membrane is recommended along the top and ends of all wooden horizontal structural members. Synthetic decking and railing systems should also be considered.

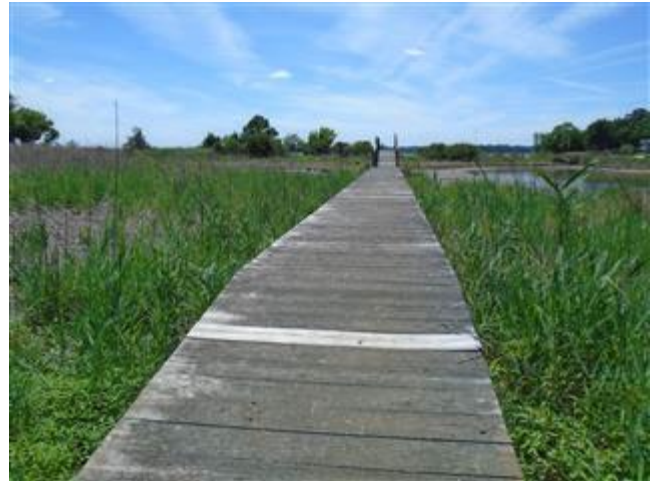
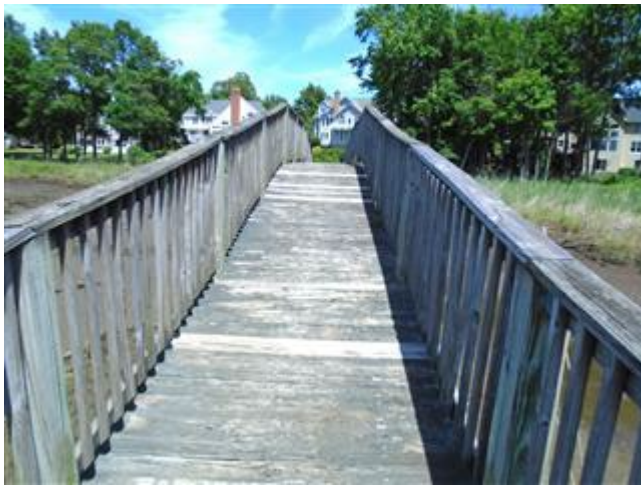
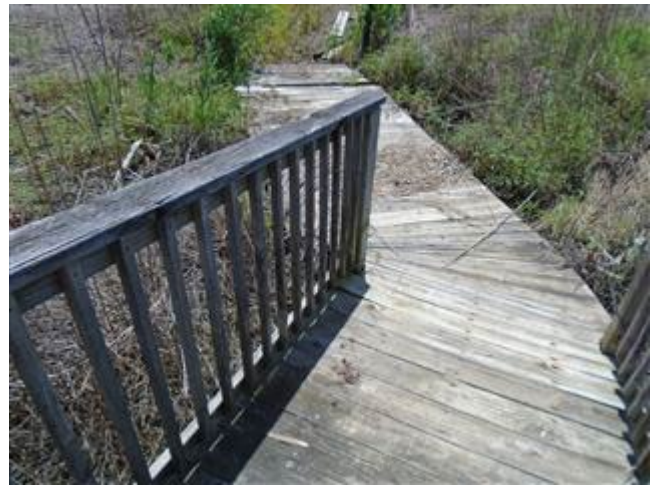
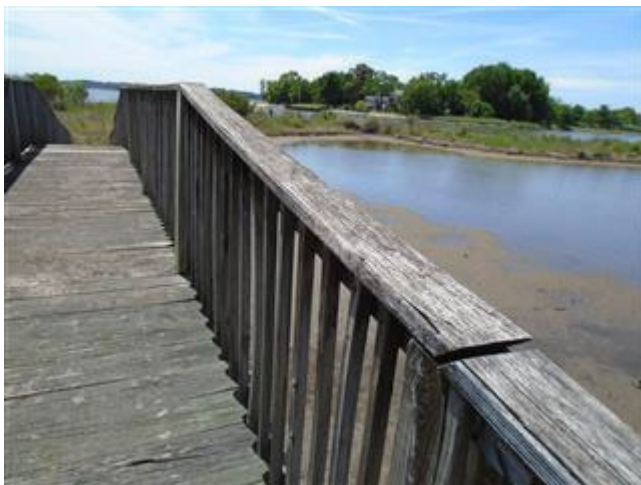
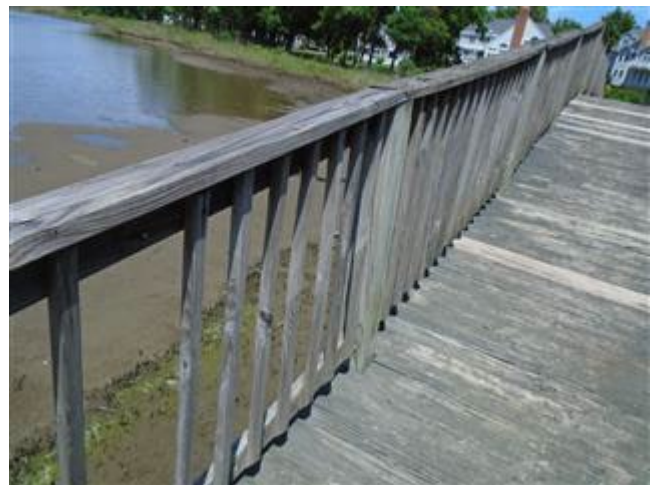
Wood Piers. The Association operates several piers. The 'crabbing' pier is a wood structure located off Hidden River View Court. The pier is constructed from pressure-treated lumber supported by wood pilings. The pier is approximately seventeen years old.

It is recommended that all piers be inspected at least once each year to identify damage to pilings, structural members, surface boards, and railings.

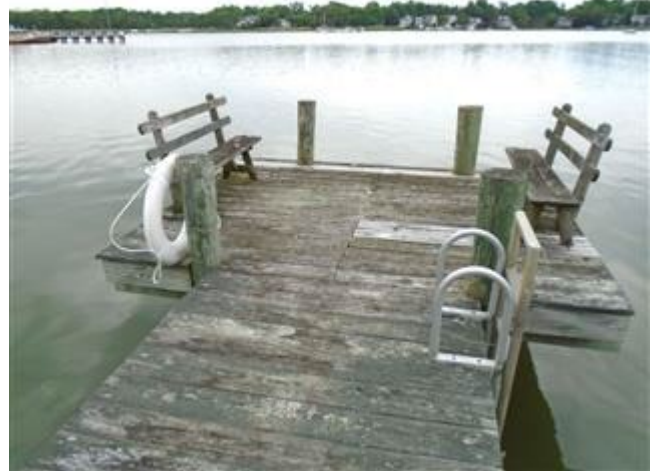
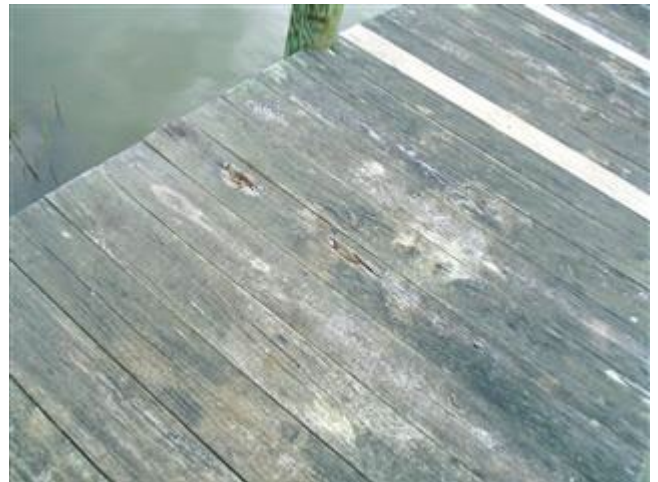
Wood Piers. The Association maintains two finger piers on opposite sides of the concrete boat launch ramp. The finger piers were constructed in or around 1990. The western pier has had a recent extension with the addition of a dock and jet ski floating dock in or around 2020. The piers are constructed from pressure-treated lumber supported by wood pilings.

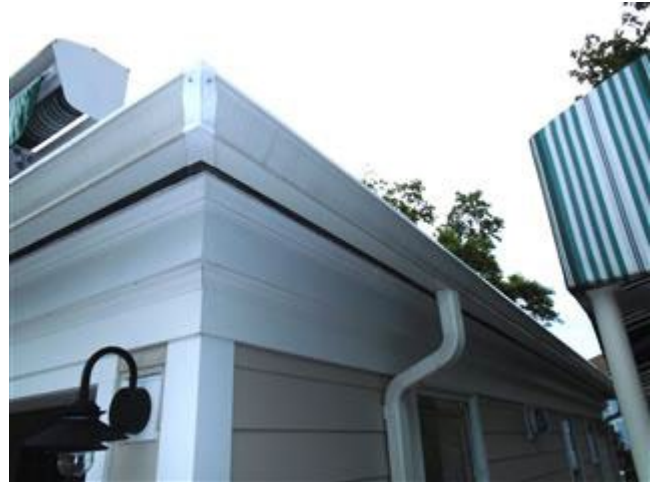
Siding and Trim. The clubhouse has cementitious siding that is in good condition.
