## CONDITION ASSESSMENT

**General Comments.** Miller-Dodson Associates conducted a Reserve Study at Fishing Creek Farm in June of 2012. Fishing Creek Farm HOA is in generally poor and mixed condition for a community constructed in 1990. A review of the Replacement Reserve Inventory will show that we are anticipating most of the components achieving their normal economic lives.

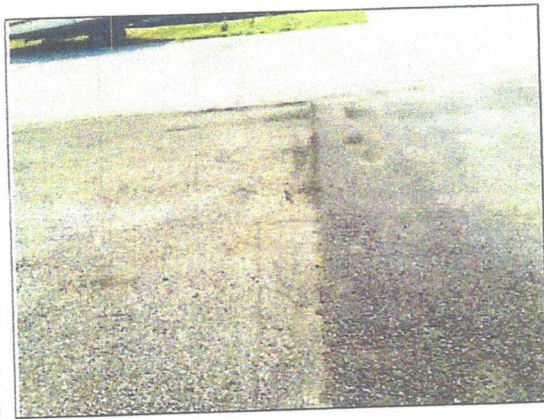
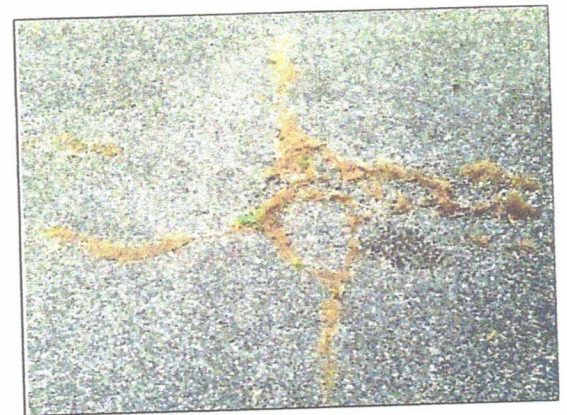
**Asphalt Pavement.** The Association is responsible for the parking area at the pool, and a small area at the tennis court. This study also includes Southbreeze Lane which is marked as a private road and does not have the standard turn-around bulb at its end. The other roadways within the community are maintained by the city, county or other municipality. In general, the Association's asphalt pavements are in fair to poor condition, with wide cracking and patches. The Association maintains an inventory of about 16,500 square feet (sf) of asphalt pavement, with Southbreeze Lane being an additional 8,200 sf.

As a rule of thumb, asphalt should be overlaid when approximately 5% of the surface area is cracked or otherwise deteriorated. The normal service life of asphalt pavement is typically 18 to 20 years. However, given the condition of other community components, we have modeled the deferral of the overlay work for six years and recommend repair and seal coating in the current year of this study.

In order to maintain the condition of the pavement throughout the community and to ensure the longest life of the asphalt, we recommend a systematic and comprehensive maintenance program that includes:

3. **Seal Coating.** The asphalt should be seal coated every three to five years. For this maintenance activity to be effective in extending the life of the asphalt, cleaning and crack repair should be performed first.

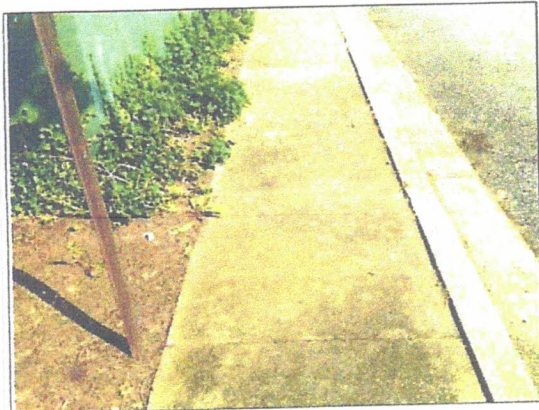
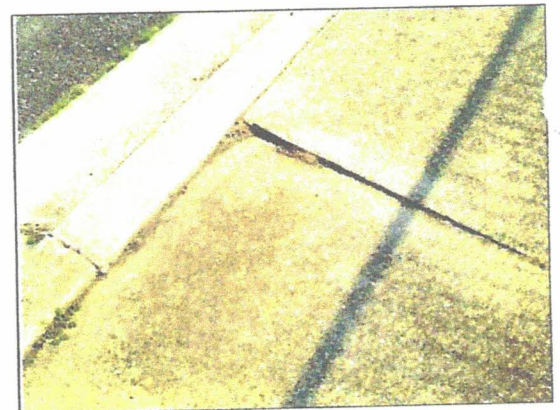
**Concrete Work.** The concrete work includes primarily the community curbs and sidewalks at the community build parking lot. The Association maintains an inventory of approximately 2,300 square feet (sf) of concrete flatwork and about 500 linear feet (ft) of concrete curb. We have modeled for curb replacement when the asphalt pavement is overlaid. The overall condition of the concrete work is fair with a few tripping hazards and other defects.

Because it is highly unlikely that all of the community's concrete components will fail and require replacement in the period of the study, we have programmed funds for the replacement of these inventories and spread the funds over an extended timeframe to reflect the incremental nature of this work. This approach assumes an average failure rate of ½% to 1% per year.

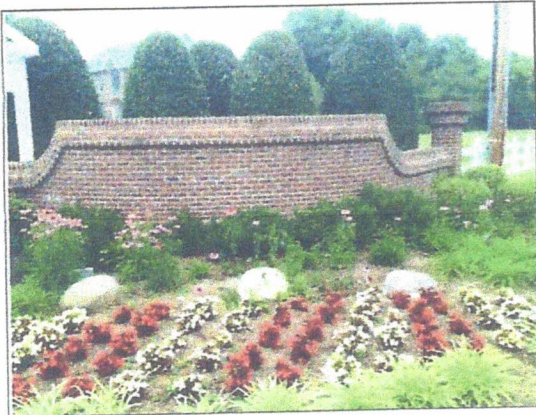
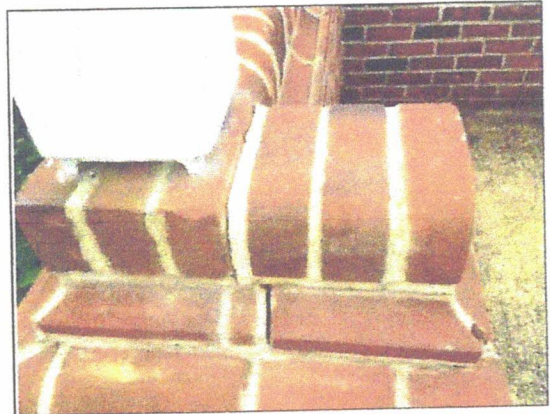
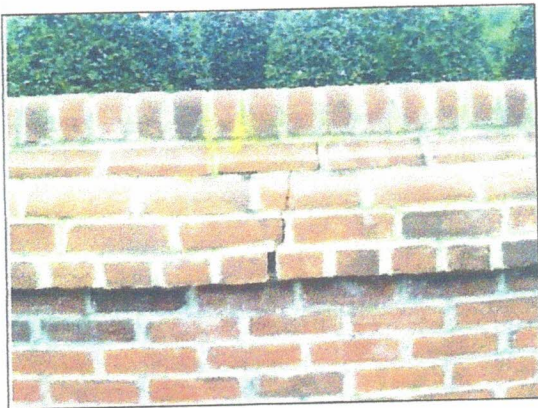
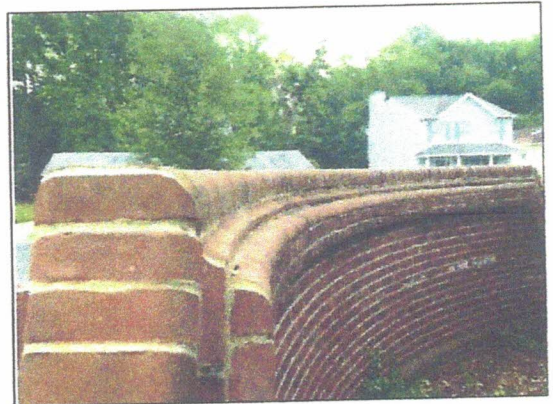
**Entry Monument and Signage.** The Association maintains several entry monuments. The monuments are made of brick masonry and are in fair condition, with open masonry joints and loose and broken masonry units.

We recommend repointing and replacement of defective areas of the masonry, and have accounted for 10% of this work every 10 years. The Association may want to consider applying a coat of Siloxane or other appropriate breathable sealant to mitigate water penetration and further degradation of the masonry work. For additional information, please see the appropriate links on our web site at <http://mdareserves.com/resources/links/building-exterior>

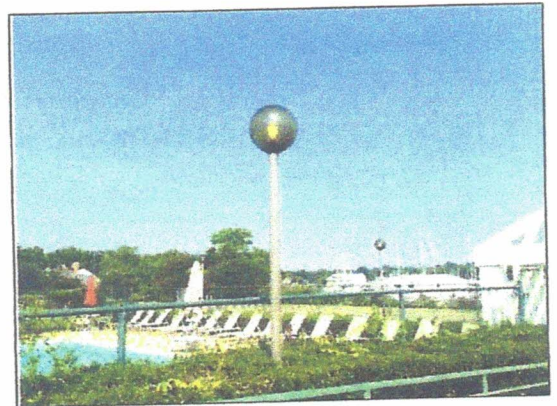
**Site Lighting.** The Association is responsible for the operation of the pole lights located at the parking lot and pool. The lighting system was on at the time of our site visit, but appears worn with a mix of repairs.

This study assumes replacement of these light fixtures every 20 years, and that these lights will be replaced when the parking lot is overlaid. When the light poles are replaced, we assume that the underground wiring will also be replaced.

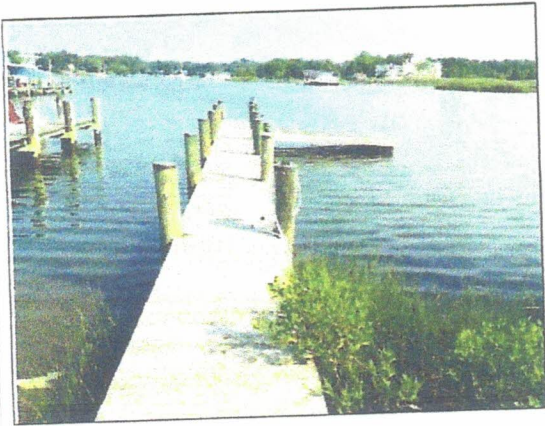
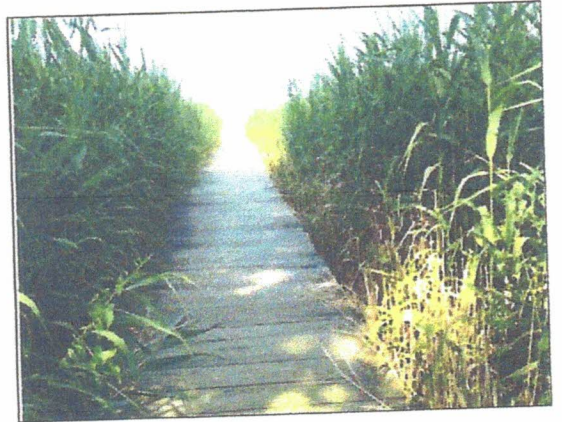
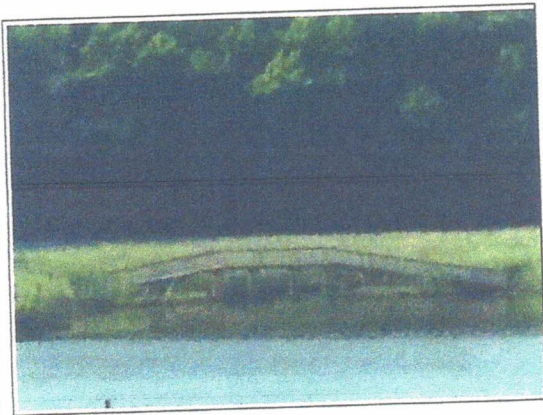
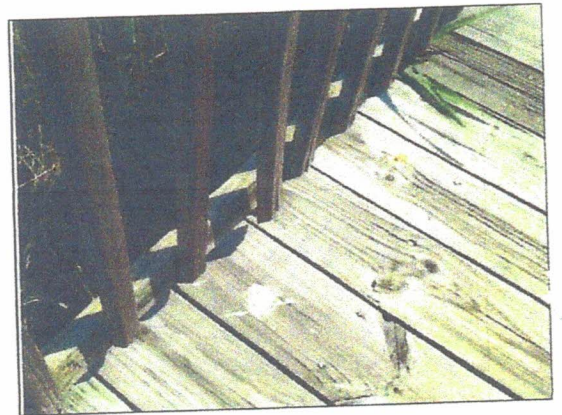
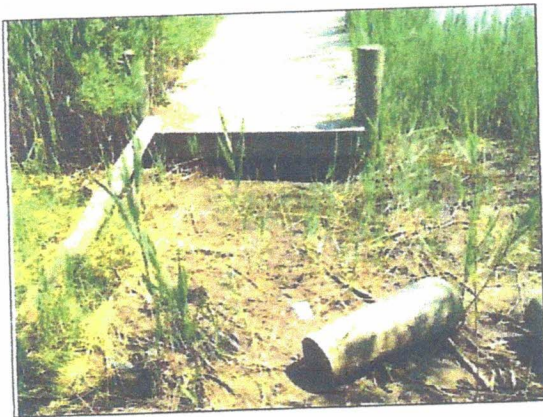
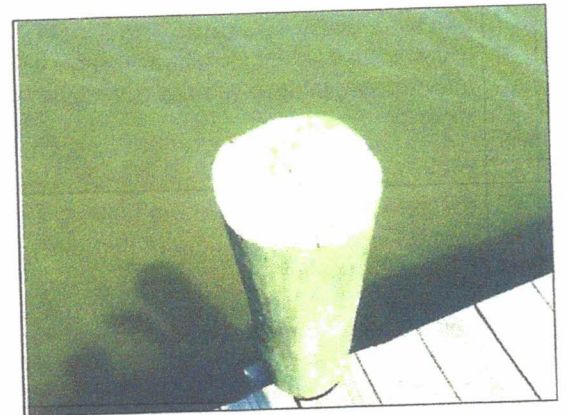
**Wood Walks, Piers and Bridge.** The community maintains an inventory of wood walks, piers, and a bridge. The crab pier has had a significant amount of erosion at its entrance and the addition of an access ramp is recommended to tie the elevation of the pier to the surrounding topography. In addition the pile caps are uncovered. In other locations railings are loose and some deck planks are rotting or lifted.

We have assumed that when these components are replaced they will be replaced with similar materials.

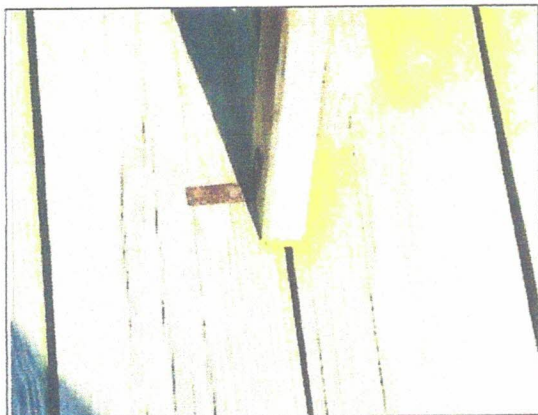
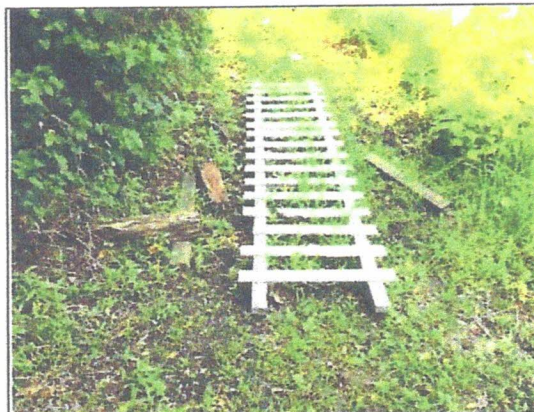
Also at the crabbing pier, two benches are poorly mounted to the end of the pier, and we recommend removing the benches or providing a more secure mounting and bench system.

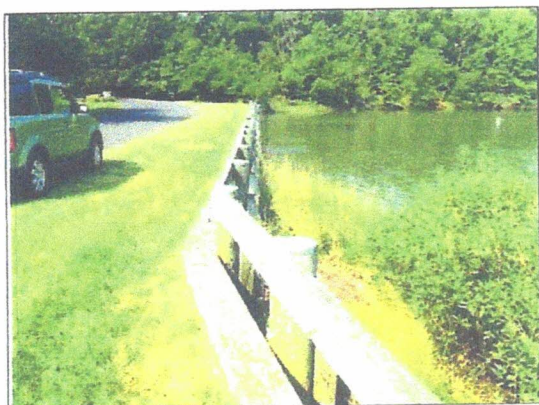
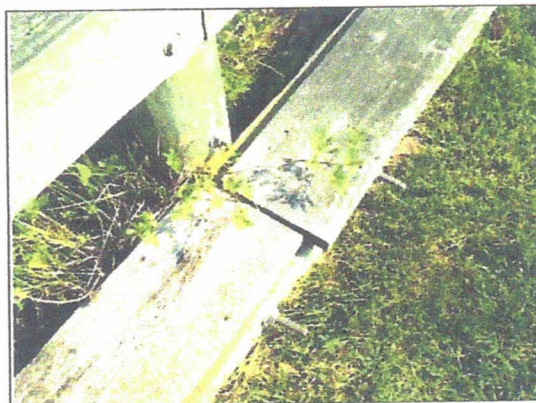
**Bulkhead.** There is a wood bulkhead extending along a portion of the community that is in generally good condition, with only minor settlement and erosion along the back side of the bulkhead. The cap boards are split and loose in some locations and to preserve the top of the wall portions of the bulkhead, we recommend removing and replacing the cap boards as needed along, with an annual inspection.

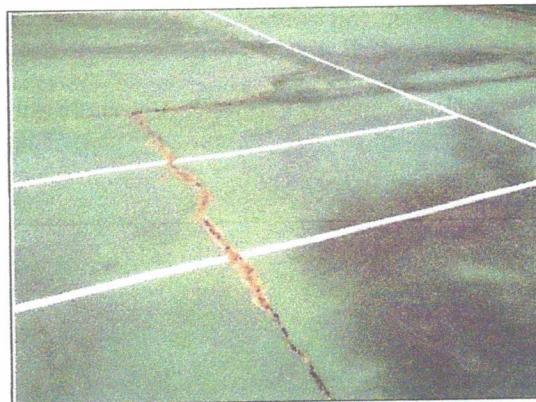
**Tennis Courts - Asphalt.** The community maintains a single tennis court. The overall condition of this court is poor, with wide cracking in many locations that extend into the playing surface. We have assumed a service life of 20 years for the asphalt. When the surface is reconstructed, we recommend replacing the fencing, posts, and footings.

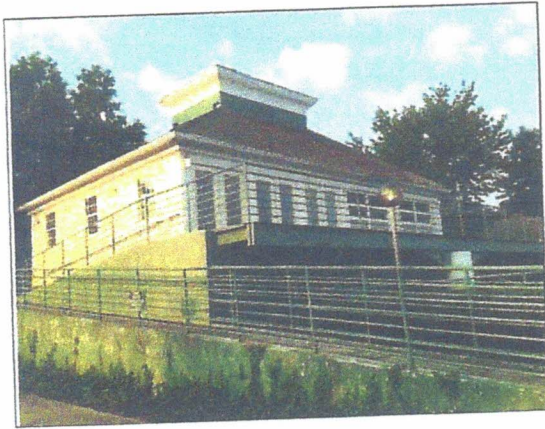
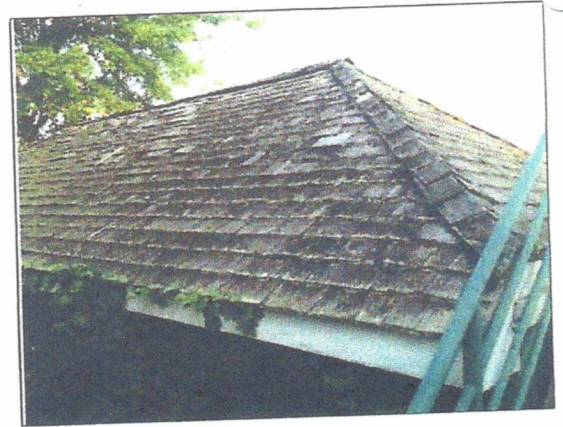
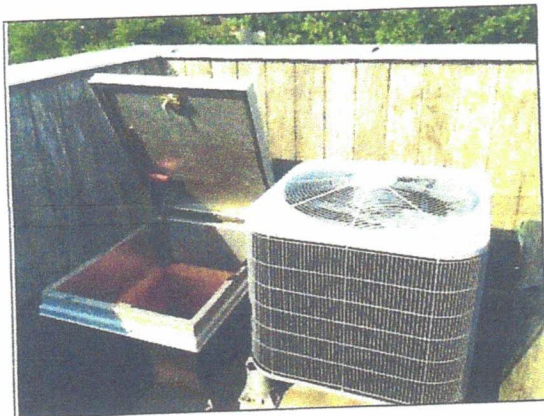
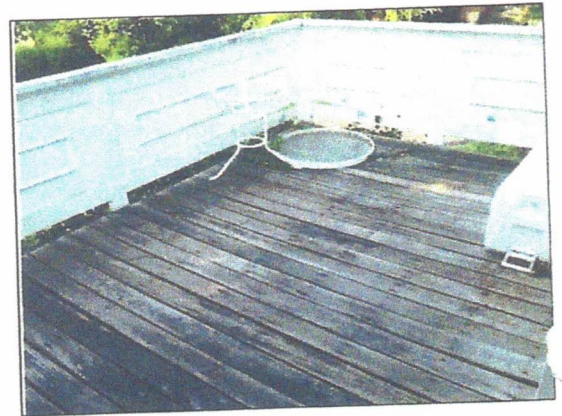
**Building Roofing.** The community buildings are roofed in cedar shake shingles and a flat membrane roofing system. These roofing systems are at the end of their useful lives.

Cedar shake roofing is expected to have a useful life of about 30 years, but the system installed is in poor condition. We have assumed a synthetic cedar shingle system for the sloped roofs of the main and mechanical community buildings.

Flat roofing systems can have a variety of configurations that will greatly affect the cost of replacement including insulation, ballast and the height of the building. We have assumed a 30 years roofing system for the flat upper area and front deck of the main community building.

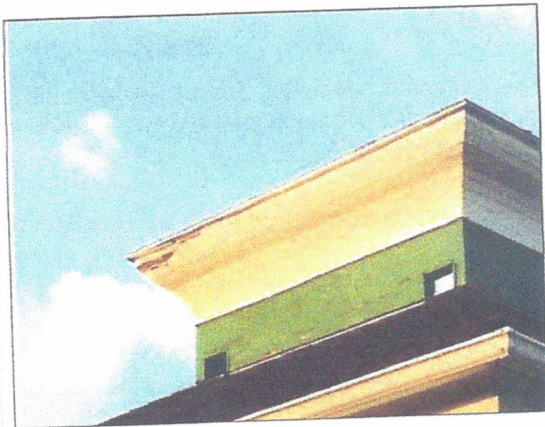
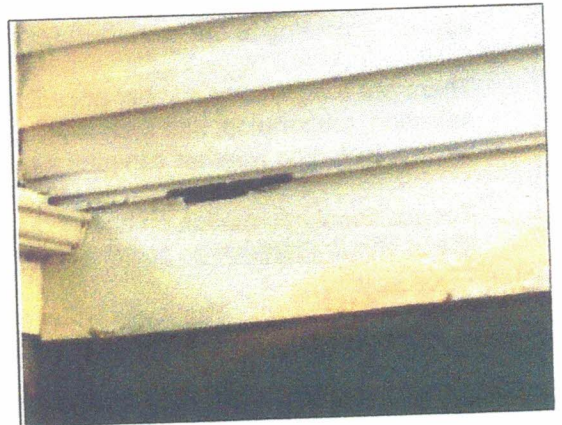
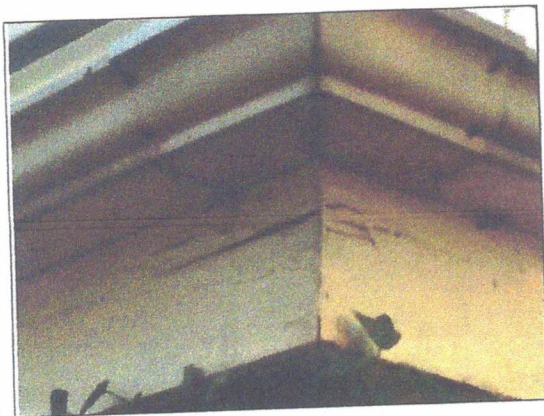
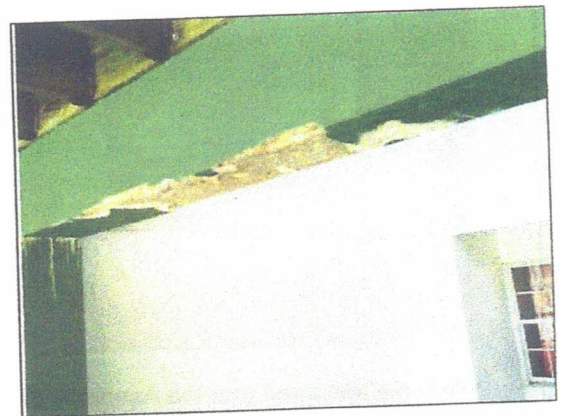
**Siding and Trim.** The exteriors of the community building are in poor condition with wood rot and stucco failure in many locations.

As an alternative to high-maintenance materials such as wood, this study assumes that the Association will want to consider replacements using low maintenance synthetic or cementitious materials. For additional consideration, please see the related articles "Alternative Trim Materials - A Replacement for Wood Trim?" and "An Examination of New Materials - Cement Fiber Composites" on our web site at <http://mdareserves.com/resources/links/building-exterior>.

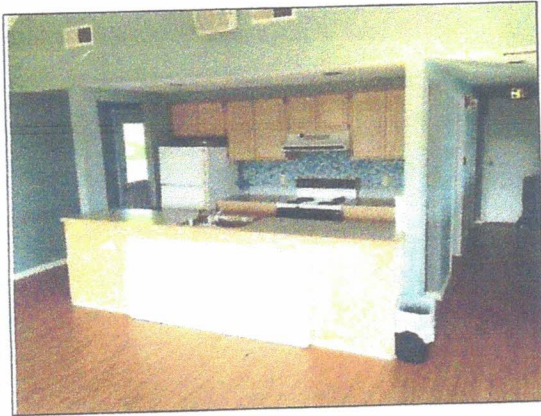
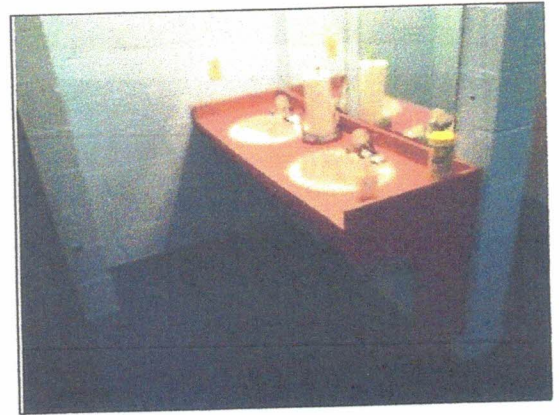
**Common Interiors.** The Association maintains the interior of the main community building which is in generally worn condition.

We have assumed that the Association will want to maintain these areas in a commercially acceptable condition. Typically, replacement cycles for common interior spaces vary between 5 and 10 years depending on the aesthetic tastes of the community, usage, and construction. Material selection and the community's preferences are the major factors in setting the reserve components for items such as refurbishing and interior refurbishment. The Association will need to establish these cycles as these facilities age. Maintaining historical records and incorporating these trends and preferences into a future Reserve Study update is the best way to adjust for these cycles.

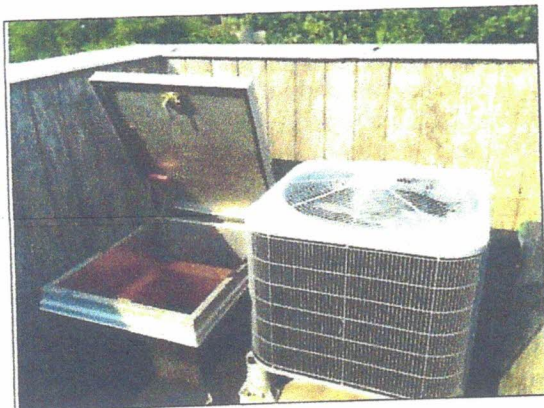
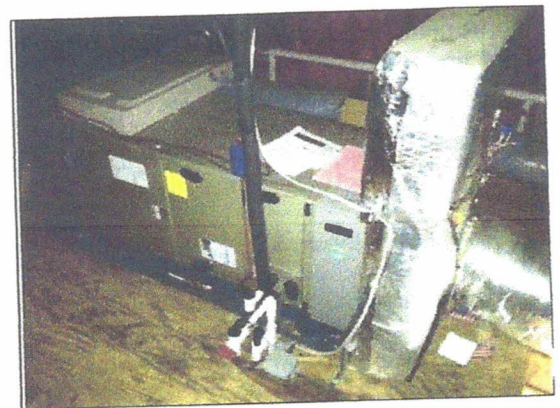
**Split and Package HVAC Systems.** The Association maintains a heating ventilation and air conditioning (HVAC) systems that use one of the new generation refrigerants. Unlike the old R22 refrigerant, the new refrigerants are expected to be available throughout the period of this study. However, the operating pressure for new refrigerant systems is approximately twice as high as older systems. Many of the standard components have not been redesigned for these higher pressures, including the coils, which generally fail due to metal fatigue.

Even though manufacturers continue to predict 15 to 20-year life cycles for HVAC equipment that use these new refrigerants, this is not proven by historical data. We therefore recommend anticipating a normal economic life of 12 years for all HVAC equipment that uses pressurized refrigerants of these types.

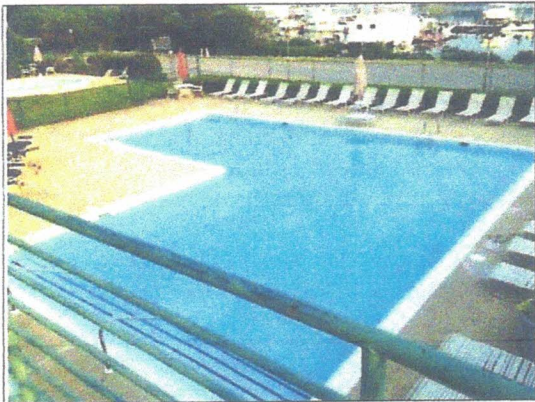
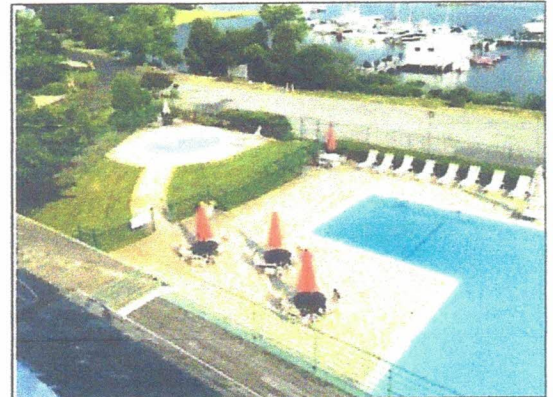
**Swimming Pool.** The community operates an outdoor pool and wading pool of concrete construction with a concrete deck. The concrete deck is not coated.

- **Pool Shell.** The shell for the swimming pool is in good condition. Pool shells normally have a finite life of approximately 45 years. At that time it may not be necessary to replace the entire structure. However, it is prudent to anticipate a major expenditure for replacement of underground lines and sections of the pool. Based on our research, we have found it to be prudent to program \$65 per square foot of pool surface to cover these needs.

- **Pool Deck.** The pool has a concrete deck. The overall condition of the deck is good.
- **Whitecoat.** The pool whitecoat is in good condition. We have assumed a service life of eight to ten years for the pool whitecoat.

- **Coping.** The pool is edged with masonry brick coping. The coping is in good condition.
- **Waterline Tile.** The waterline tile is in fair condition. We have assumed that the waterline tile will be replaced or restored when the pool is whitecoated.

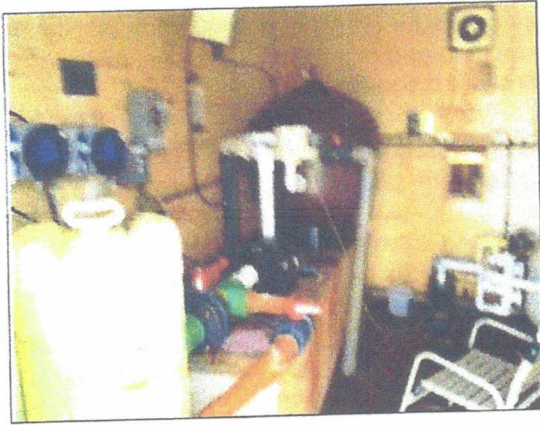
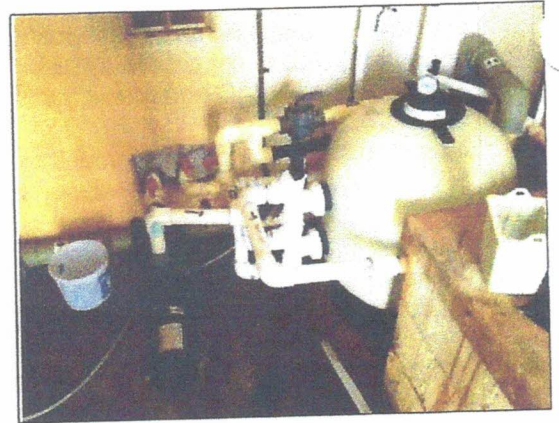
- **Pump and Filter System.** The pump and filter systems were operational at the time of inspection. We have assumed a service life of 15 years for the filter systems, and 5 years for the pumps.

However, in the parking lot near the wade pool and sidewalk adjacent to this pool, water was observed and it is reported that this area is constantly wet. We recommend pressure testing the wade pool lines and inspecting the skimmer systems to see if there is a leak that is in need of repair.
