MARINA and SHORELINE CONDITION SURVEY

**Fishing Creek Farm
Anne Arundel County, Maryland**

September 26, 2012

AMA/DBF 2307A001.001

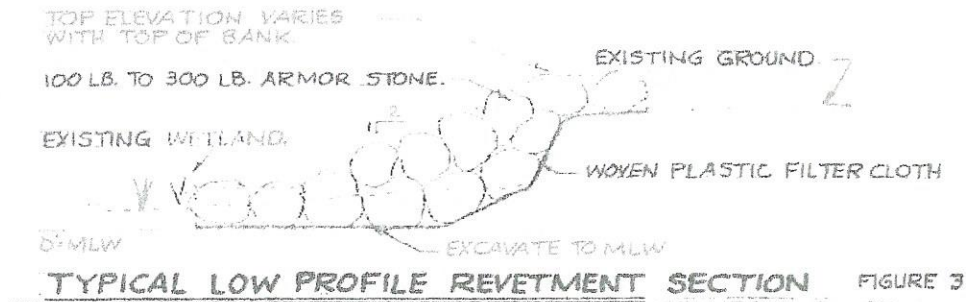
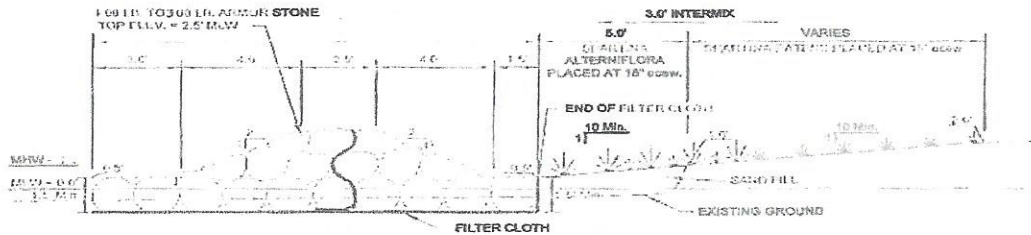
Spartina alterniflora and *Spartina patens* sprigged into imported sand fill (Figure 4) should be constructed at an estimated cost of \$390 to \$460/ft. Except for sprigging wetland vegetation into the existing ground; environmental approvals are required prior to any construction activities.

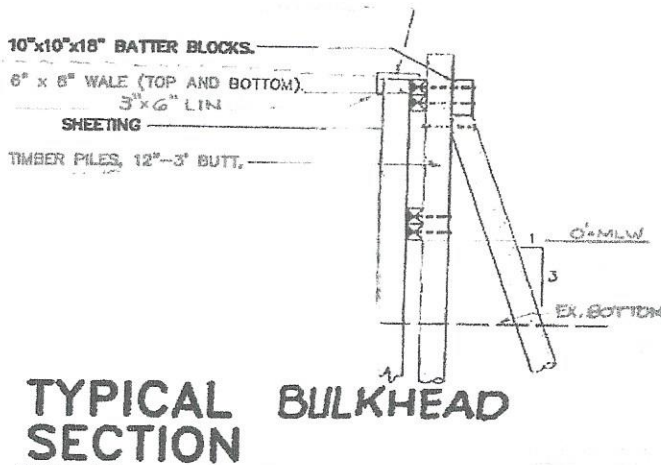
BULKHEADED SHOULDER ALONG CHERRYTREE LANE: Approximately ¼ mile east of the Clubhouse along the northerly shoulder of Cherrytree Lane, a timber bulkhead (+/- 240 L.F.) protects the paved roadway against erosion from tidal waters of Duvall Creek (Photo 9). The batter pile supported bulkhead appears to be in generally good condition except for twisted and warped timber capboards and evidence of minor soil leakage (Photo 10) at several locations. It appears that the existing structure had previously replaced an older bulkhead. Decayed anchor rods (>1" dia.) extend landward through the existing T&G sheeting from the existing bulkhead's vertical pile. AMA/DBF theorizes that this rod is attached to the earlier bulkhead's buried anchor piles thereby creating a redundant anchorage system. It is AMA/DBF's opinion that the existing timber bulkhead has >15 years of life remaining before significant improvements are needed; however, if replaced (Figure 7), the estimated cost would be from \$900 to \$1200/LF.

AMA/DBF recommends that the capboard be replaced and the sump areas be repaired when funding becomes available. The estimated cost for these improvements is on the order of \$4K to \$8K.

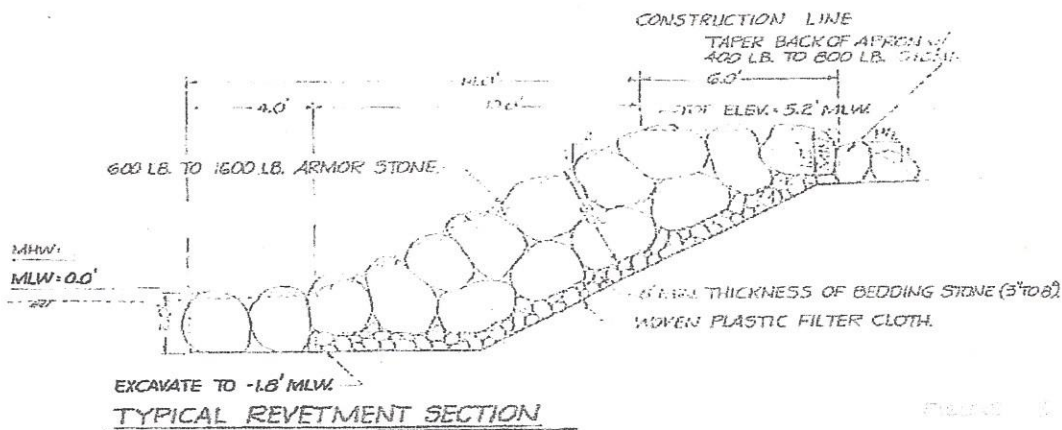
Time during our visit did not allow investigating the shoreline located west of the existing revetment. However, according to the "Historic Erosion Rate Map" (Figure 1) and aerial photographs showing fallen trees along the shore, this area is actively experiencing erosion. No upland improvements at the site are endangered by erosion. It is AMA/DBF's opinion that construction of a "Living Shoreline" at this location would not be appropriate due to wave conditions generated by the >5 mile fetch. In the event FCF elects to prevent the continuing erosion of the shoreline at this location, AMA/DBF recommends construction of a stone revetment (Figure 8) at a cost on the order of \$500 to \$600/ ft.
