MARINA and SHORELINE CONDITION SURVEY

**Fishing Creek Farm
Anne Arundel County, Maryland**

September 26, 2012

**ANDREWS, MILLER AND ASSOCIATES
A Division of Davis, Bowen & Friedel, Inc.
106 N. Washington Street
Easton, Maryland 21601**

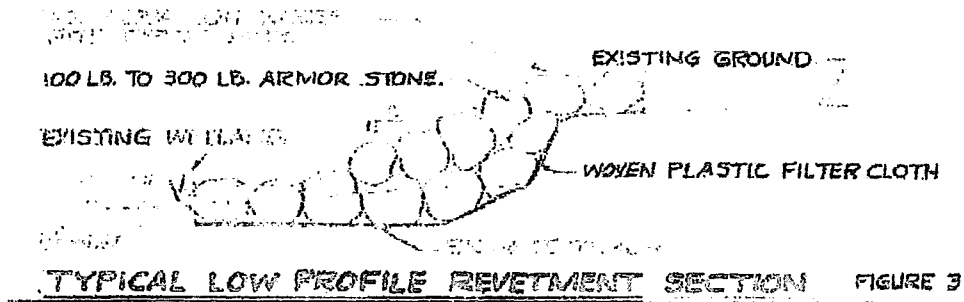
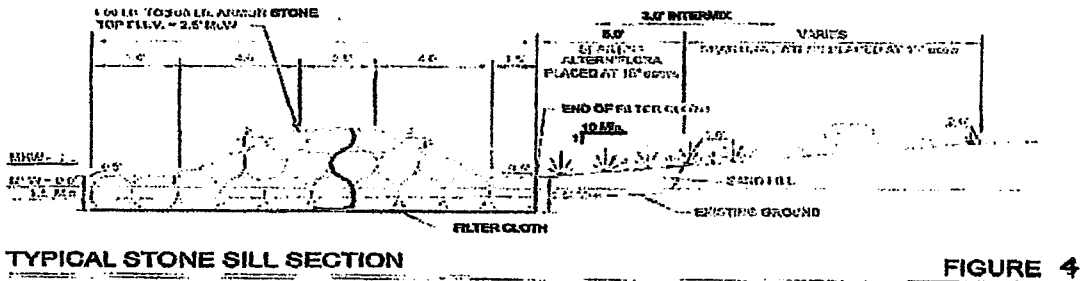
Spartina alterniflora and *Spartina patens* sprigged into imported sand fill (Figure 4) should be constructed at an estimated cost of \$390 to \$460/ft. Except for sprigging wetland vegetation into the existing ground; environmental approvals are required prior to any construction activities.

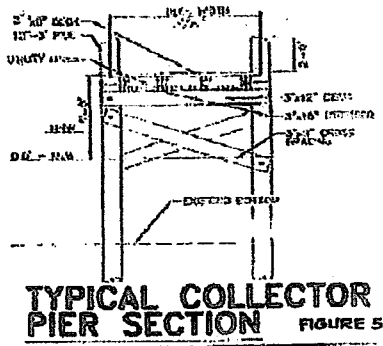
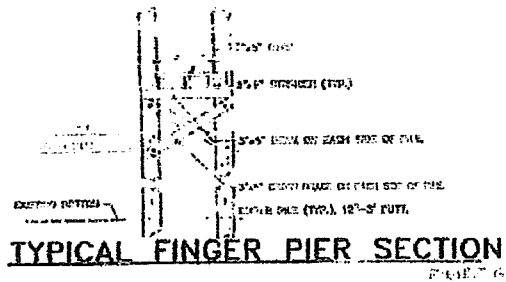
MARINA: The existing community marina is a fixed timber pier facility. Amenities include water, electric and sewage pumpout (Photo 7) services for the 42 slip (including 3 transient slips) facility (Photo 8). Eight feet of water provides deep water access to the slips. Boat lifts within several of the slips are the responsibility of individual slip users (boat lift, additional support piles, maintenance, etc). Except for a damaged finger pier (boat uplifted end of pier) located at the westerly end of the marina and twisted and warped deck planks, it is AMA/DBF's opinion that the collector pier, finger piers and mooring piles have >15 years of life remaining before significant structural improvements are needed. The estimated cost for replacement of the collector pier (Figure 5) is \$400 to \$450/ LF, replacement of the finger piers (Figure 6) is \$7K to \$8K each, and replacement of the mooring piles is \$700 to \$900 each, all as shown in Table 1.

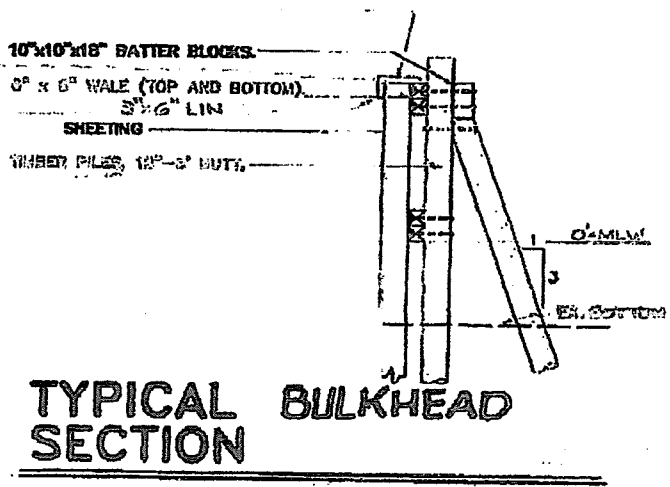
BULKHEADED SHOULDER ALONG CHERRYTREE LANE: Approximately ¼ mile east of the Clubhouse along the northerly shoulder of Cherrytree Lane, a timber bulkhead (+/- 240 L.F.) protects the paved roadway against erosion from tidal waters of Duvall Creek (Photo 9). The batter pile supported bulkhead appears to be in generally good condition except for twisted and warped timber capboards and evidence of minor soil leakage (Photo 10) at several locations. It appears that the existing structure had previously replaced an older bulkhead. Decayed anchor rods (>1" dia.) extend landward through the existing T&G sheeting from the existing bulkhead's vertical pile. AMA/DBF theorizes that this rod is attached to the earlier bulkhead's buried anchor piles thereby creating a redundant anchorage system. It is AMA/DBF's opinion that the existing timber bulkhead has >15 years of life remaining before significant improvements are needed; however, if replaced (Figure 7), the estimated cost would be from \$900 to \$1200/LF.

AMA/DBF recommends that the capboard be replaced and the sump areas be repaired when funding becomes available. The estimated cost for these improvements is on the order of \$4K to \$8K.

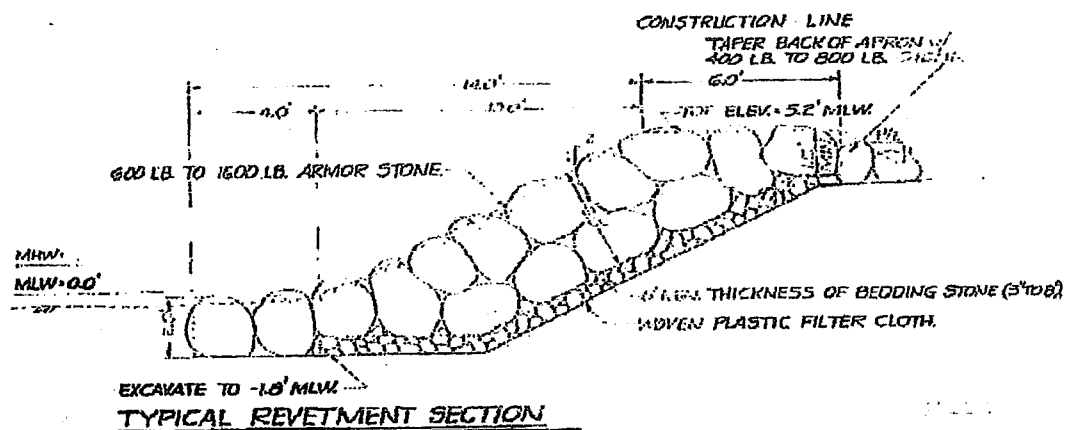
Time during our visit did not allow investigating the shoreline located west of the existing revetment. However, according to the "Historic Erosion Rate Map" (Figure 1) and aerial photographs showing fallen trees along the shore, this area is actively experiencing erosion. No upland improvements at the site are endangered by erosion. It is AMA/DBF's opinion that construction of a "Living Shoreline" at this location would not be appropriate due to wave conditions generated by the >5 mile fetch. In the event FCF elects to prevent the continuing erosion of the shoreline at this location, AMA/DBF recommends construction of a stone revetment (Figure 8) at a cost on the order of \$500 to \$600/ ft.
