LEVEL 2 REPLACEMENT RESERVE REPORT FY 2023 FISHING CREEK FARM

FISHING CREEK FARM

ANNAPOLIS, MARYLAND

June 27, 2022

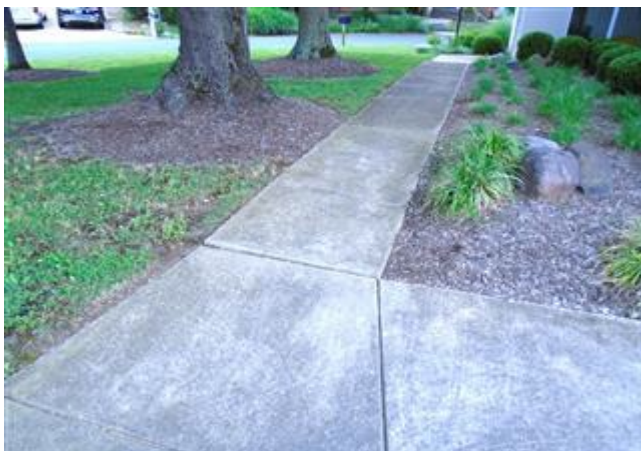
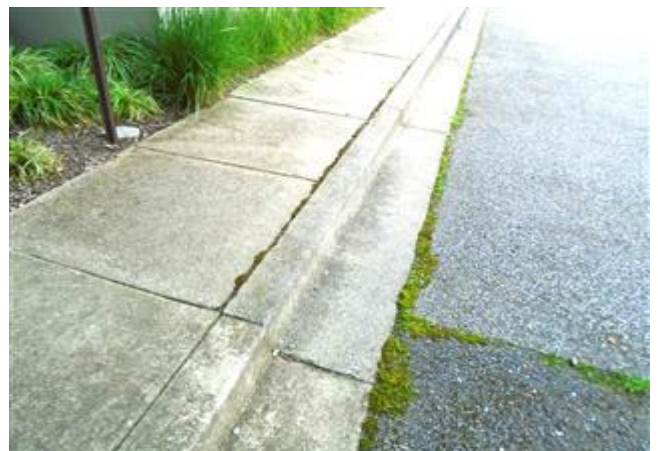
Concrete Work. The concrete work includes the pool/community center curb, gutter, sidewalk, and lead walks. (Pool deck is listed separately.) Curb replacement should be performed when the asphalt pavement is overlaid. The overall condition of the concrete work is good. It was noted the sidewalk in the parking area has subsided causing a tripping hazard and should be repaired.

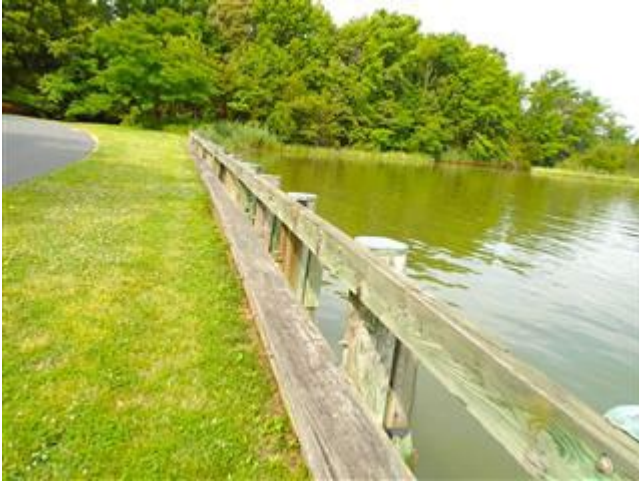
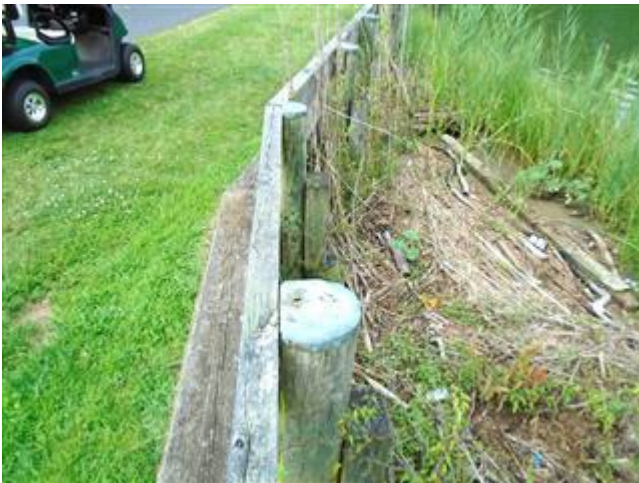
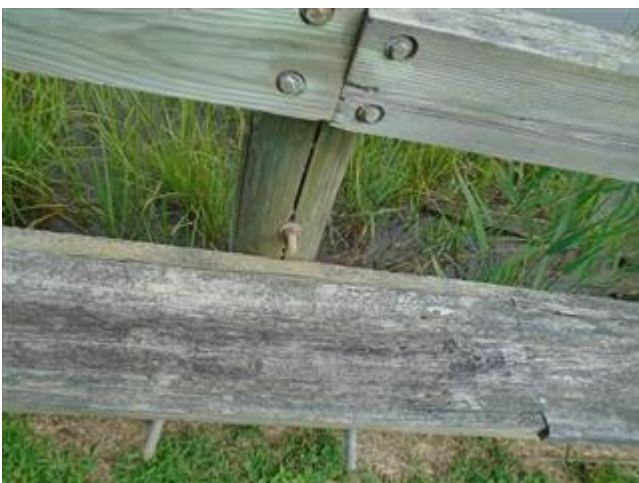
Bulkhead. The Association maintains approximately 250 ft. of wood bulkhead on the north side of Cherry Tree Lane, in the 1240 block. . The bulkhead is in fair condition. An allowance for the replacement of cap board, sheathing, and piling caps has been programmed in the analysis. In addition funds for future replacement of the bulkhead are included in the analysis.

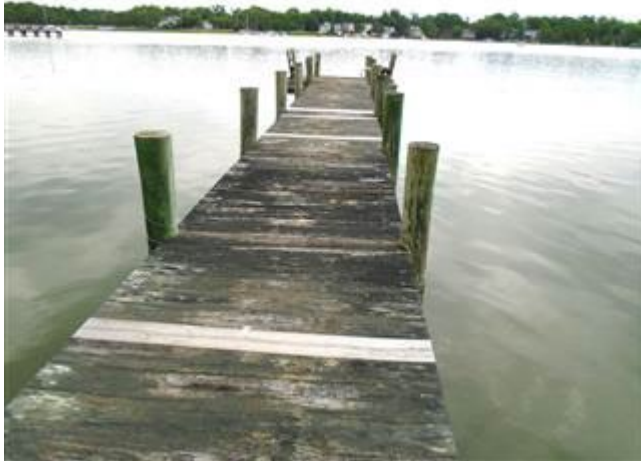
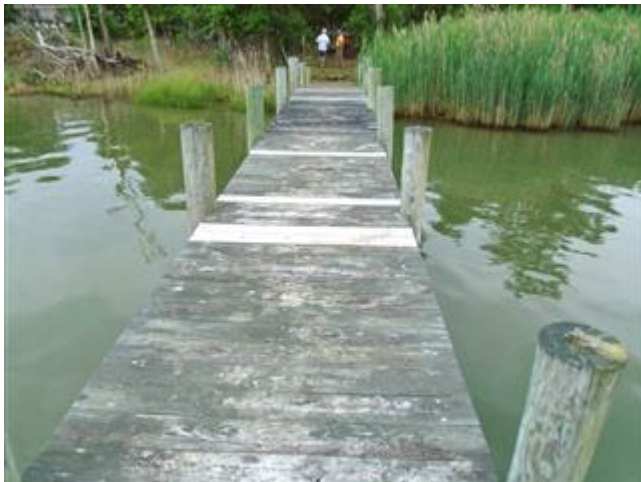
Wood Piers. The Association maintains two finger piers on opposite sides of the concrete boat launch ramp. The finger piers were constructed in or around 1990. The western pier has had a recent extension with the addition of a dock and jet ski floating dock in or around 2020. The piers are constructed from pressure-treated lumber supported by wood pilings.

The wood piers' decks are in varying conditions.

The pier structure varies in age.

It is recommended that all piers be inspected at least once each year to identify damage to pilings, structural members, surface boards, and railings.

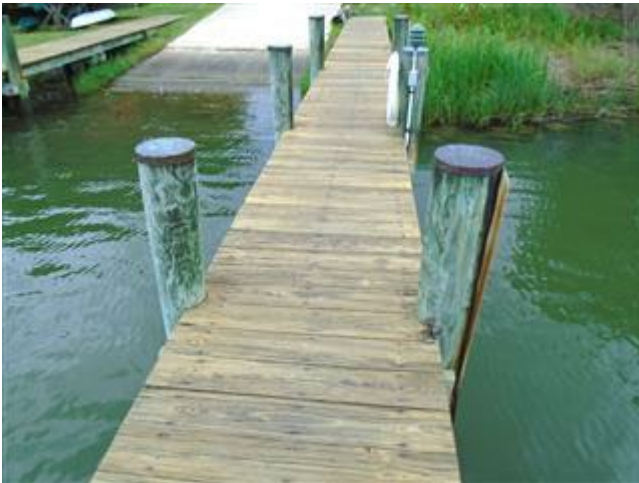
Freestanding Pilings. Freestanding pilings are those pilings that are installed at the outside limit of a floating jet ski dock. These pilings provide mooring points to secure the dock. They are not a part of the pier structure. Because these pilings can be replaced individually when required without affecting other elements of the pier structure.

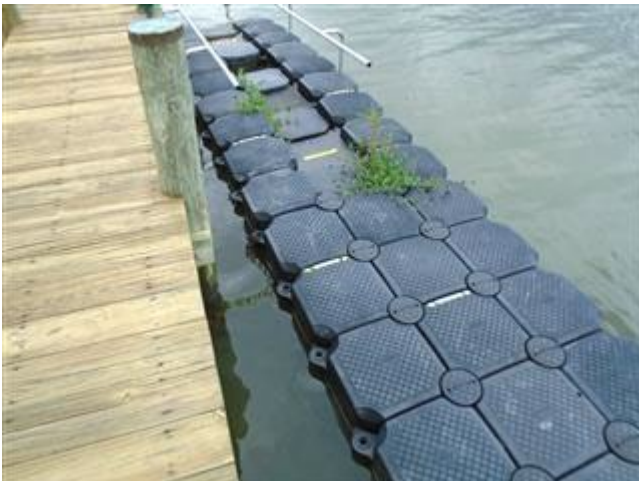
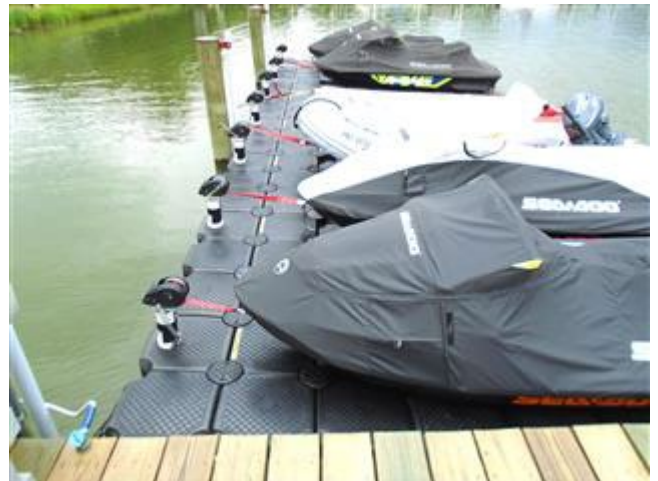
Floating Docks. The Association maintains two floating docks. One is for a kayak launch and the second is for jet ski docking. The kayak launch is in fair condition. The jet ski floating dock was recently installed and is in good condition.

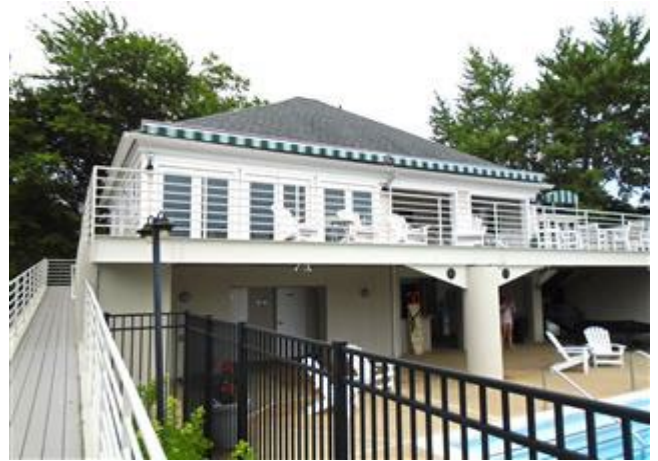
Building Roofing. The clubhouse house has an asphalt shingle roof with a section of flat membrane roofing on the Cherrytree Lane side of the building.

Flat roofing systems can have a variety of configurations that will greatly affect the cost of replacement including insulation, ballast, the height of the building, and the density of installed mechanical equipment. Flat roofing systems typically have a useful life of 15 to 25 years. The flat roof was masked by wood decking. Replacement based on age.

Annual inspections are recommended, with cleaning, repair, and mitigation of vegetation performed as needed. Access, inspection, and repair work should be performed by contractors and personnel with the appropriate access equipment who are experienced in the types of roofing used for the facility.

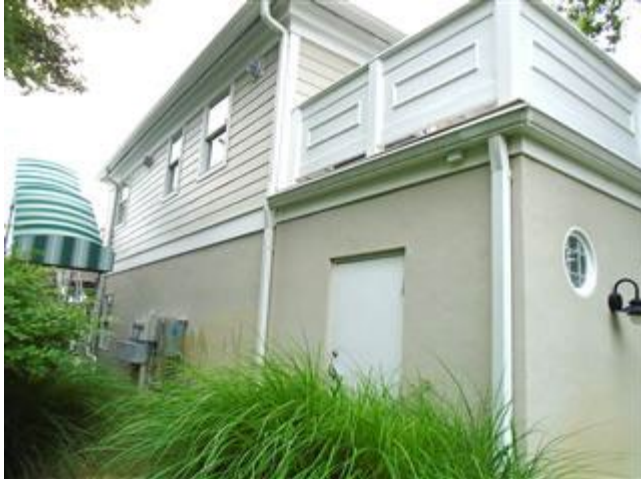
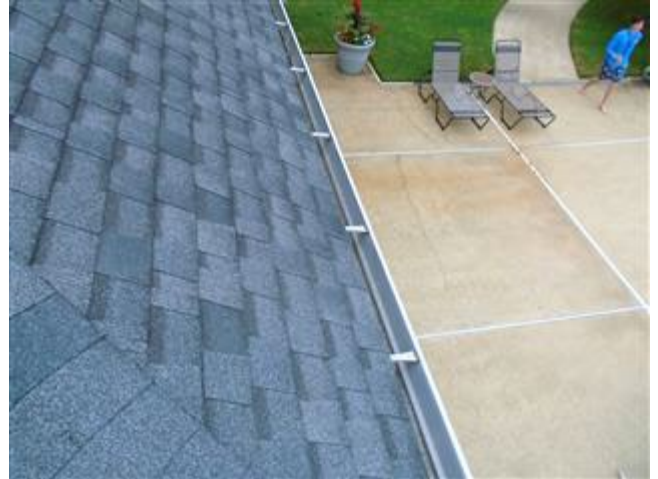
Gutters and Downspouts. The clubhouse buildings have aluminum gutters and downspouts. The gutters and downspouts are in good condition.

It is recommended that all gutters be cleaned at least twice each year. If there are a large number of trees located close to a building, consider installing a gutter debris shield that will let water into the gutters but will filter out leaves, twigs, and other debris.

It is also recommended that the discharge from the downspouts be extended at least ten feet away from the foundations.

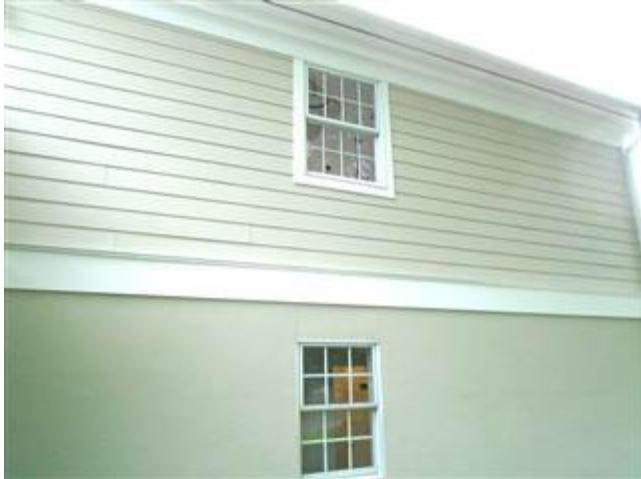
Siding and Trim. The clubhouse has cementitious siding that is in good condition.

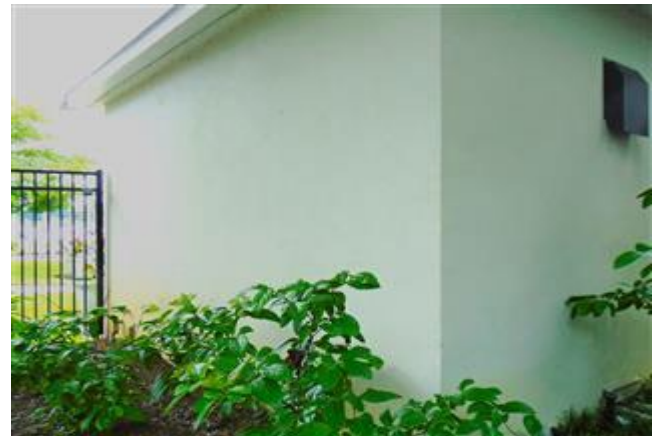
Exterior Stucco. The clubhouse facade and walls have stucco finishes. Most stucco deterioration is the result of water infiltration. This is generally first evident near the roof and around chimneys, windows, doors, and other wall penetrations. Moisture can also gain access through materials that are in contact with the ground by a process called wicking. Moisture will cause the supporting lath for the stucco to rot or corrode, resulting in the stucco pulling away from the substrate. Significant deterioration of wooden and metal structural elements can occur. Similar to Exterior Insulation Finishing Systems (EIFS) a “water-managed system” is the approach for new construction. However, many older installations assume a water barrier system. It is recommended for all stucco surfaces be inspected at least once each year.

In this study, we provide an allowance for incremental stucco repairs every 10 years with a re-coating every 30 years. Further inspection of the stucco and repair of any latent and concealed damage is not accounted for in this study.

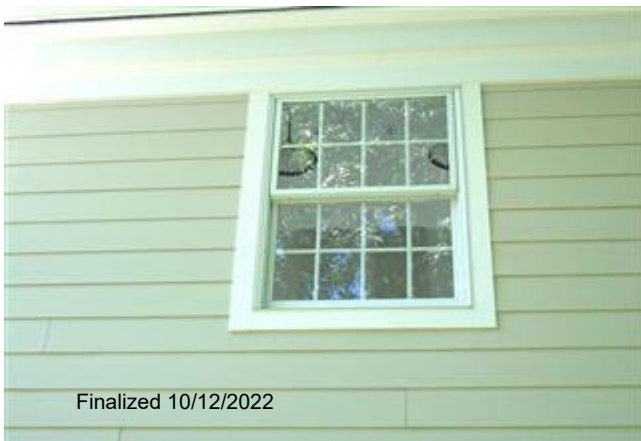
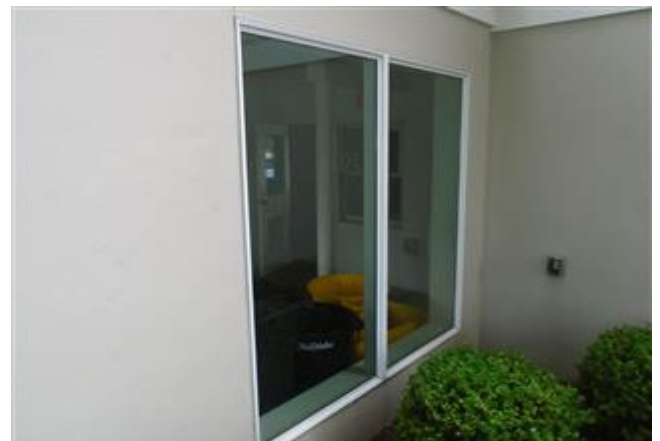
Windows and Doors. The Association is responsible for the clubhouse windows and doors. The windows and doors are generally in good condition. Some of the metal, poolside doors have corroded frames.

In general, we recommend coordinating the replacement of these units with other exterior work, such as siding and roof replacements. The weather tightness of the building envelope often requires transitional flashing and caulking that should be performed in coordination with each other. Lastly, replacements offer the opportunity to correct initial construction defects and improve the effectiveness of details with improved construction techniques and materials.

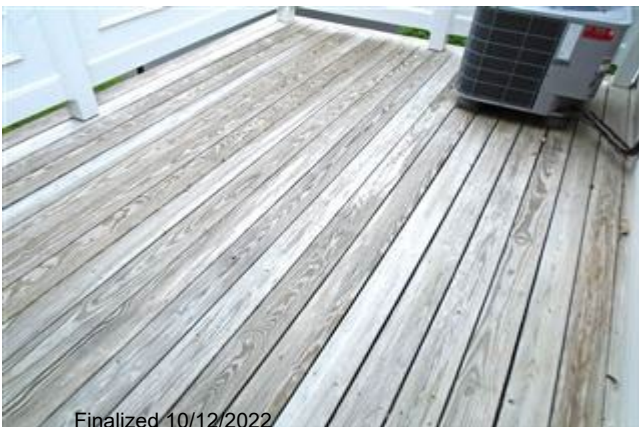
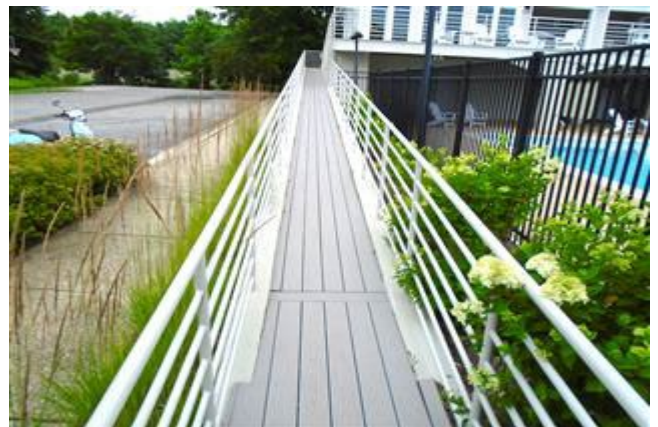
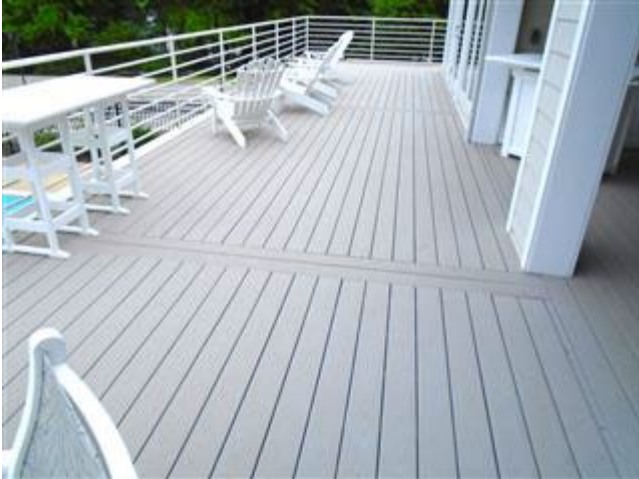
Decks. The Association maintains the clubhouse ramp, front and rear decks, and west side stairway. The ramp and decks have pressure-treated lumber structures and synthetic decking. The front deck has pressure-treated lumber decking. The ramp, decks, and stairway are in good condition.

The ramp, rear deck, and stairway have metal strand railings and the front deck has a wood surround. The railings and surround are in good condition.

We recommend for the Association implement an annual inspection program. We also recommend power washing and the application of a wood sealer with UV protection every two to three years.

When installing new decking, the installation of a self-healing flashing membrane is recommended along the top and ends of all wooden horizontal structural members. Synthetic decking and railing systems should also be considered.

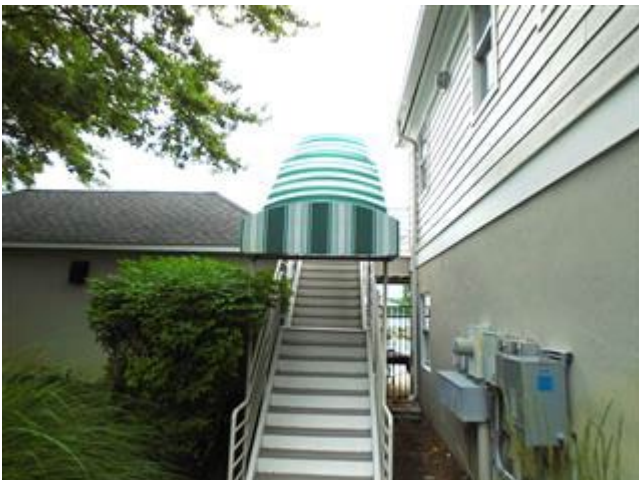
Canopy/Awning. The Association maintains a fabric cover on a metal frame canopy over the western stairway and a retractable awning on the rear deck. The retractable awning was recently installed and the stairway awning material was recently replaced. The stairway metal frame appears to be in good overall condition. We have assumed a service life of 5 to 10 years for the fabric cover and 20 to 30 years for the metal framing.

To prolong the useful life of the fabric cover, we recommend periodic cleaning and the application of an appropriate sealant.

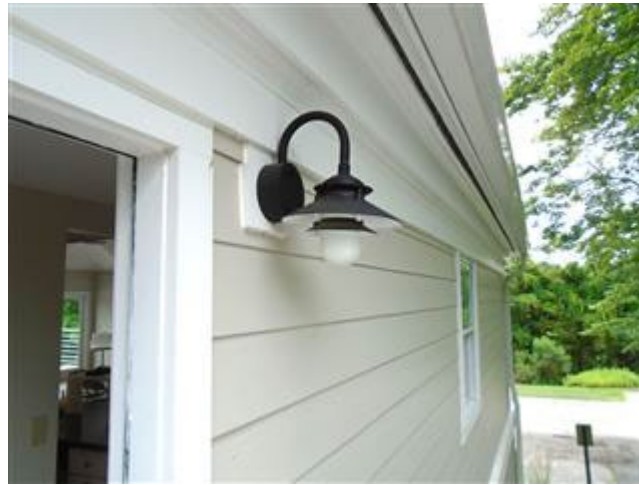
Exterior Lighting. The clubhouse exterior is illuminated with a series of wall-mounted and pendant lights. The lights were not on at the time of site visit and are assumed to be in good working order. Funding for future replacements has been programmed in the analysis.

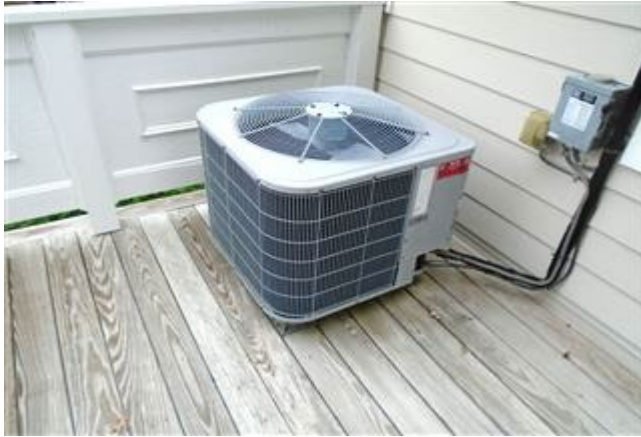
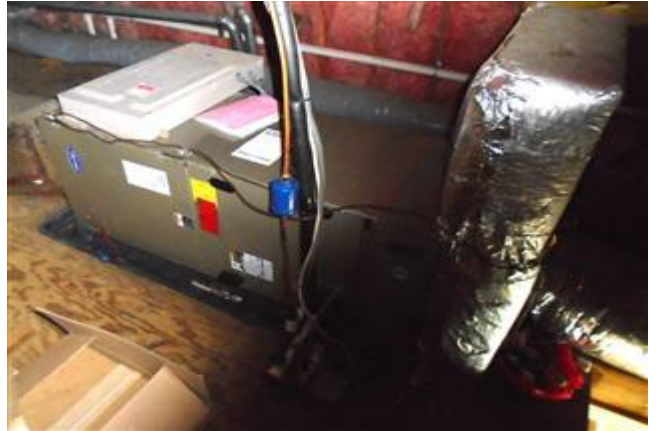
Heat Pump. There is a single 3.5-ton heat pump that serves the building. We have included two items in the Reserve Analysis for the heat pumps: the heat pump system and air handler. For the system, we have assumed a service life of 15 years. The unit was manufactured in June 2010.

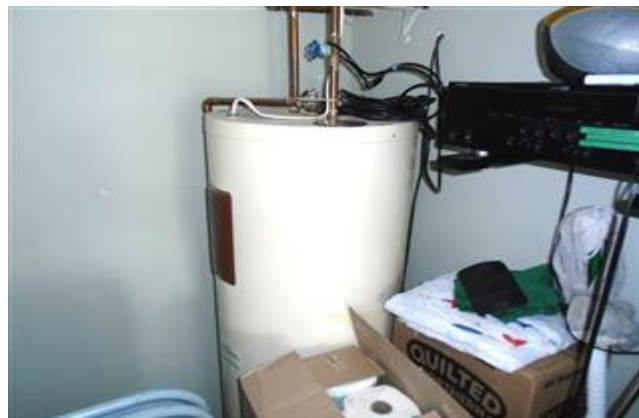
Water Heater. Domestic hot water is supplied by a single, residential-grade, electric water heater. There were no reported issues with the water heater. The base of the water heater should be kept clear. Future funding for replacement has been programmed in the analysis.

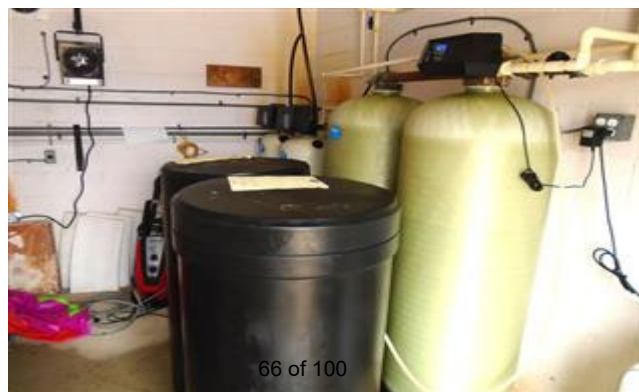
Water Treatment System. We have included an allowance for the replacement of the water treatment system. The system has had recent work and is in good working order. Conversation with Phelps provided an estimated replacement cost for the system that has been programmed in the analysis.

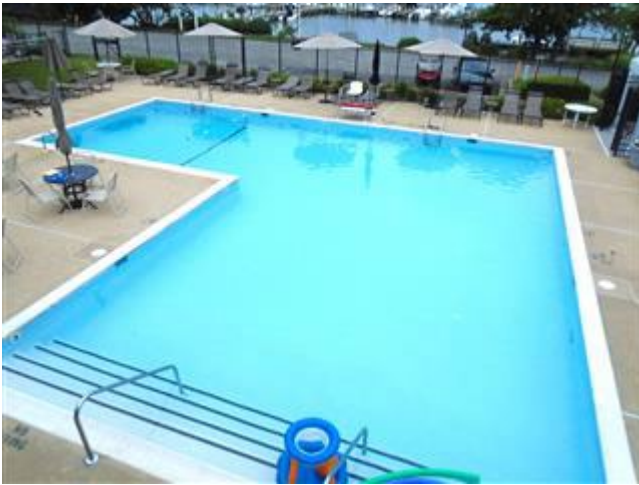
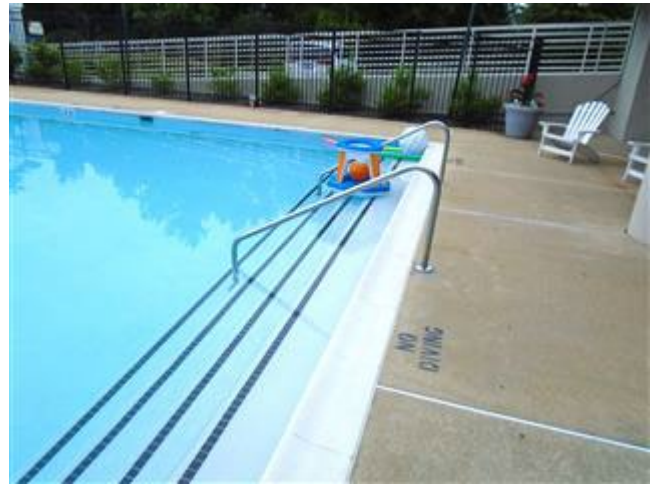
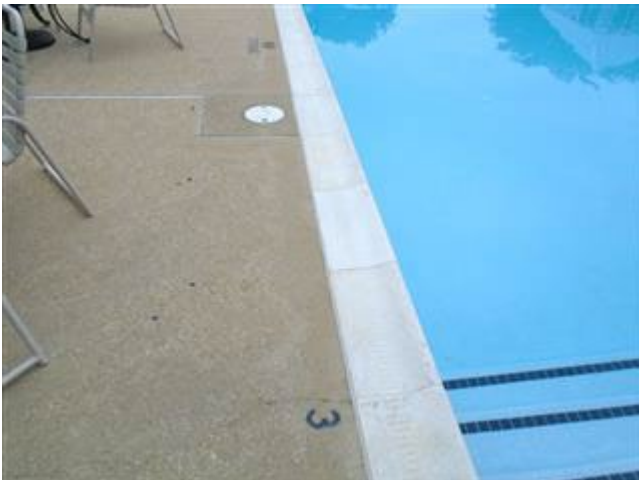
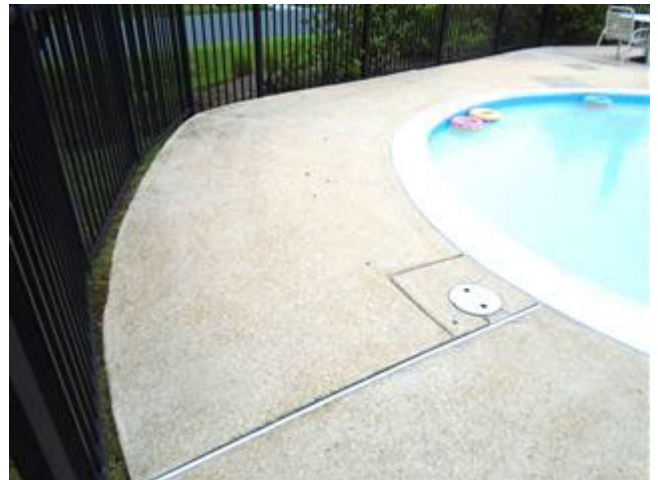
- Pool Shell. The shell for the swimming pool appears to be in good overall condition.
- Pool Deck. The pool has a concrete deck. The overall condition of the deck is good, with limited cracking. An allowance for a percentage replacement of the deck has been programmed in the analysis.

- Whitecoat. The pool whitecoat has been assumed to be in poor condition. There was no information provided by the Association or the pool service provider. We have assumed a service life of eight to ten years for the pool whitecoat.

- Waterline Tile. The waterline tile has been assumed to be in poor condition. We have assumed that the waterline tile will be replaced or restored when the pool is whitecoated.

- Coping. The pool is edged with cast concrete tile. The coping has been assumed to be in poor overall condition.
- Pumps and Filter Systems. The filter systems are in varying conditions.

- Pool Fence. The swimming pool is enclosed by an aluminum picket fence that is in good condition.
- Furniture. The Association maintains a significant inventory of pool and deck furniture. The furniture is in good condition.

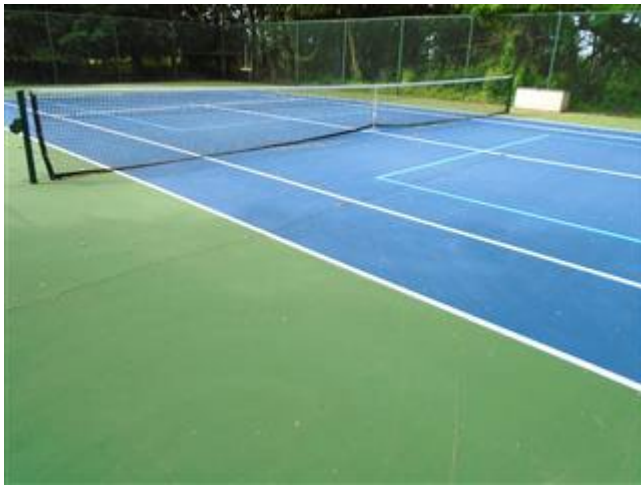
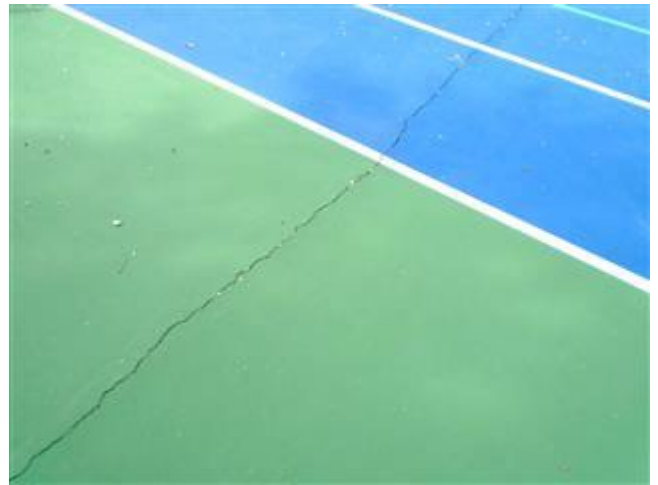
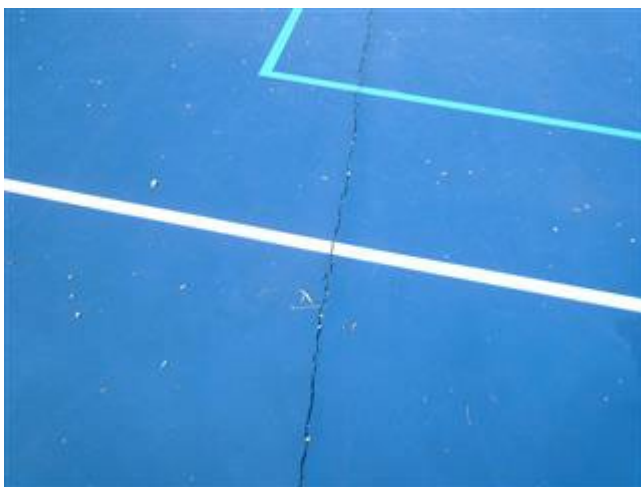
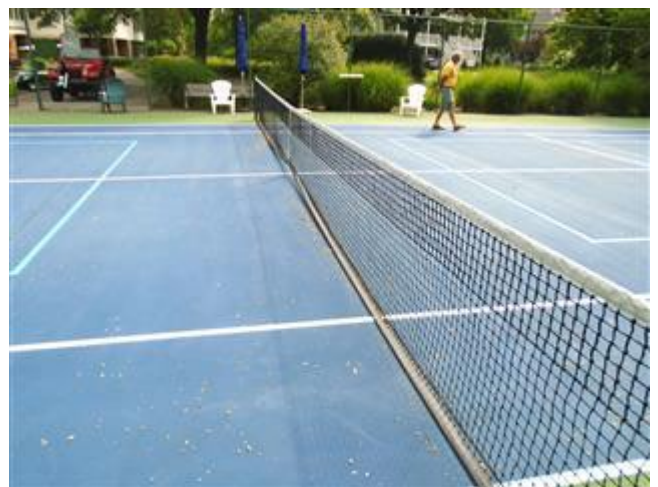
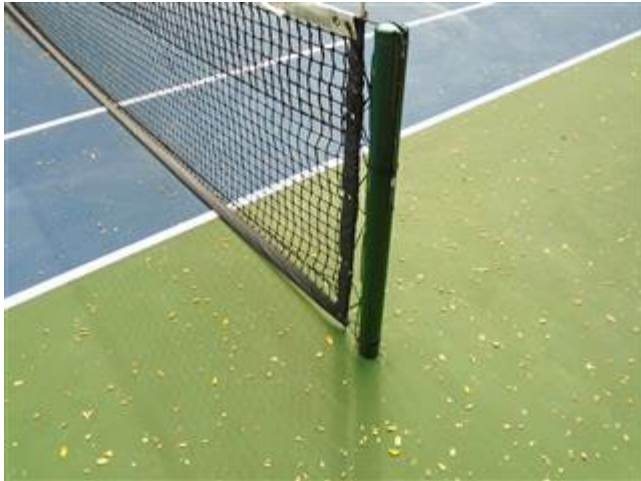
Tennis Court. The community maintains a single tennis court in the 1200 block of Cherry Tree Lane. The court was recently top coated and new lines for the pickleball court were applied. The overall condition of the court is good. There is a lateral crack on one side of the court. This crack should be resealed as needed.

- Fencing. We have assumed that the fencing will be replaced when the asphalt pavement is replaced. Posts and fencing should be inspected, repaired, and painted as needed to prolong their economic life. Periodic inspection of the posts, gates, hinges, and latches is also recommended, and it is important that posts and footings be protected to prevent soil erosion.

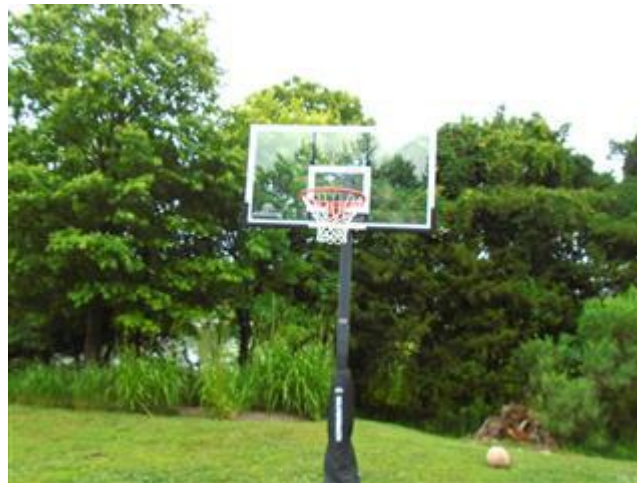
Basketball Goal. The Association maintains a single basketball hoop in the clubhouse parking area. The hoop is in good overall condition.

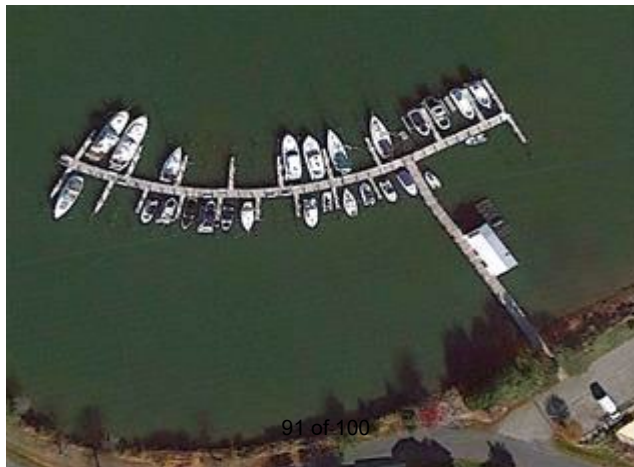
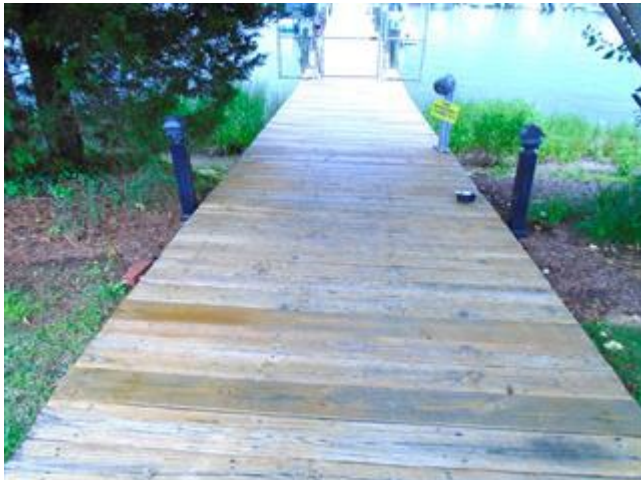
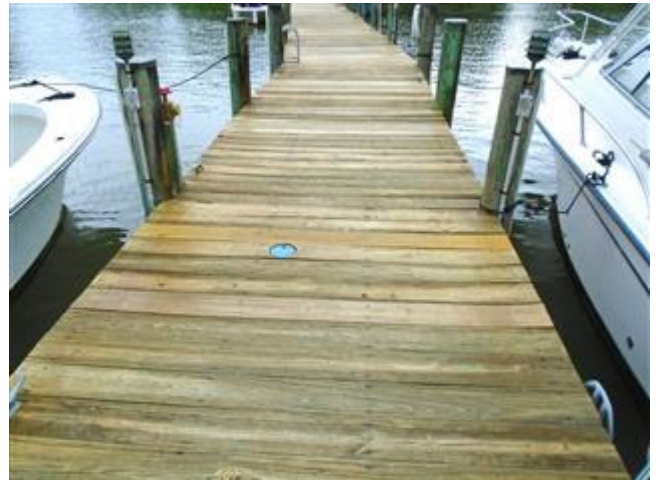
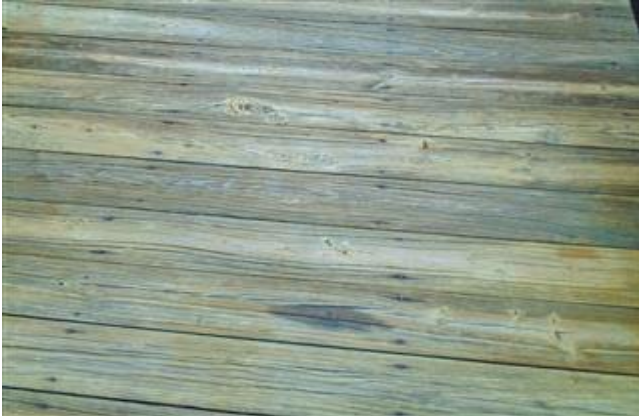
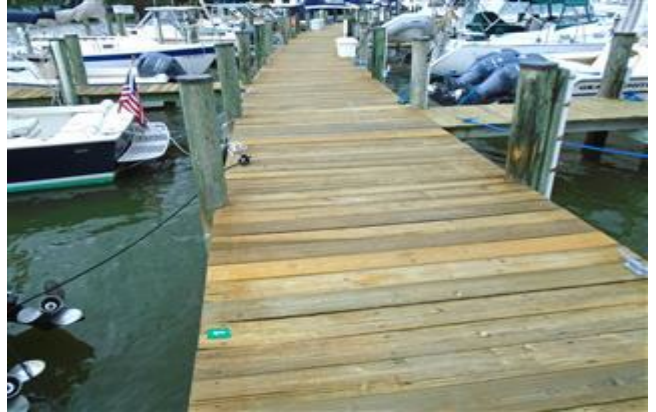
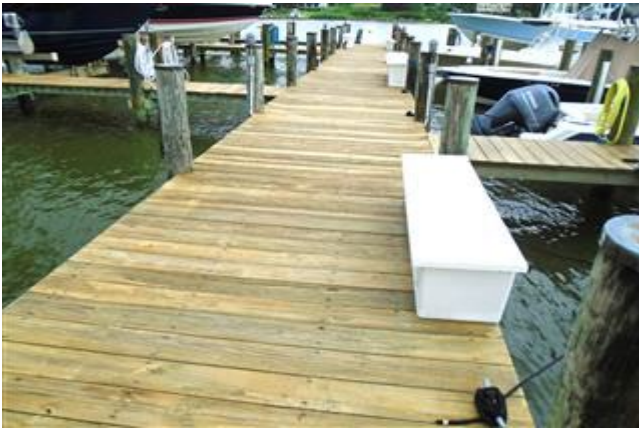
Wood Piers/Docks The Fishing Creek Farm has a marina located on Duvall Creek. The pier and dock are comprised of wood piling, pressure-treated lumber structure, and decking. In addition, there are multiple finger piers. The pier and slips were developed in three phases. It appears the first section of the pier was built in or around 1990, the west portion of the facility in 1999, and the eastern portion in or around 2006. The funding for the future replacement of the marina's dock components is based on the estimated age of the components.

Wood Pier Decking. The wood decking on the piers, the finger piers, and the wood walk is exposed to harsh extremes of sun and weather. It will typically require replacement before the heavier members of the underlying structure. This decking will also be removed and replaced in its entirety when the underlying structure is replaced. To model this replacement pattern, we have provided for a complete replacement incident to the replacement of the structure, and we have included an additional replacement interval for the wood pier decking at the midpoint of the service life of the underlying structure.

It is recommended that all piers be inspected at least once each year to identify damage to pilings, structural members, surface boards, and railings.
